NPDES Permit Number: MAR12AN23

Project Name: **Roadway Reconstruction**
Project Address: Littleton Road, Route 110
Westford, Massachusetts
Project Proponent: MassDOT/ Town of Westford
CM-002S (433)x
HIS-002S (433)x
STP-002S (433)x
Report Prepared By: Mary Trudeau, Environmental Monitor
Date of Report/Site Visit: Site inspection on **May 1, 2014**

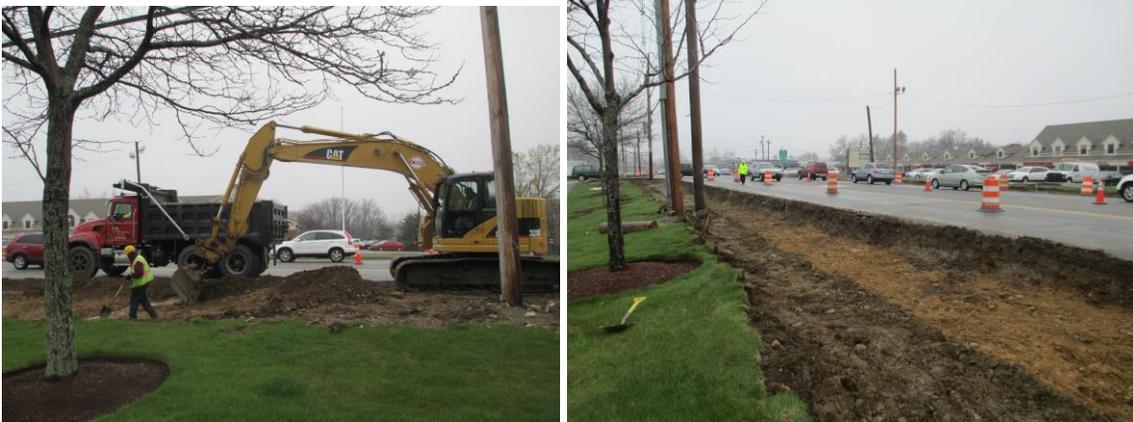
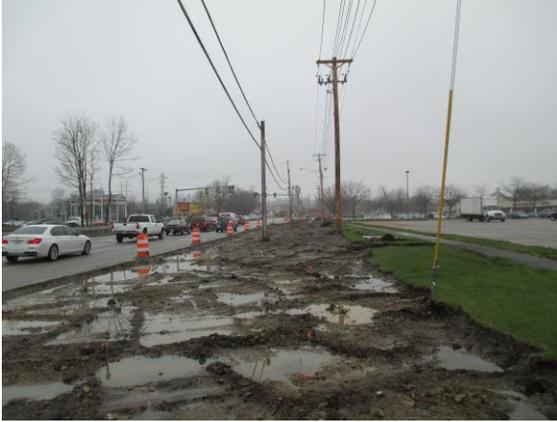
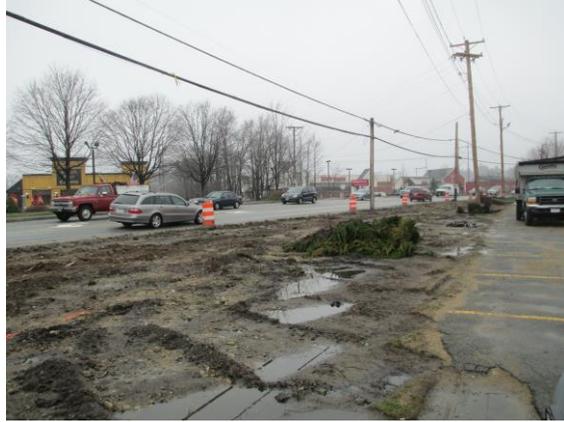
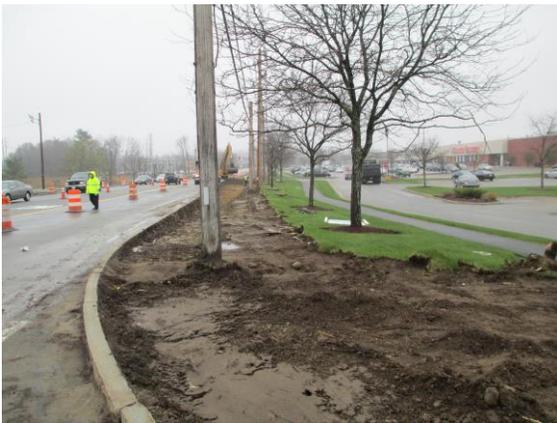
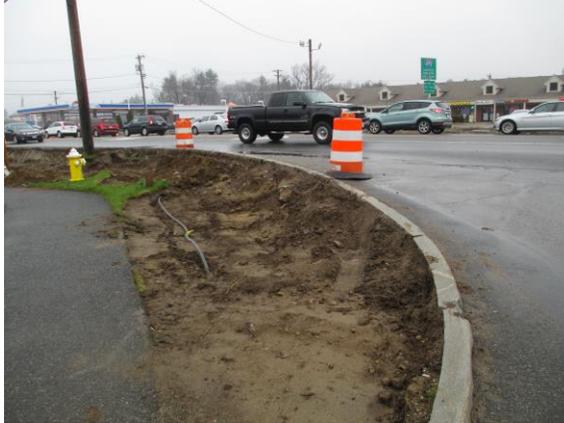
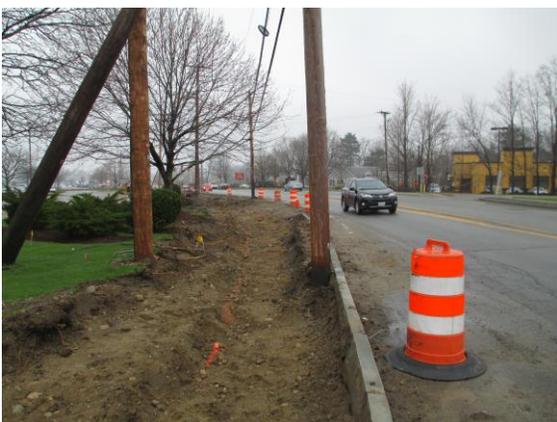
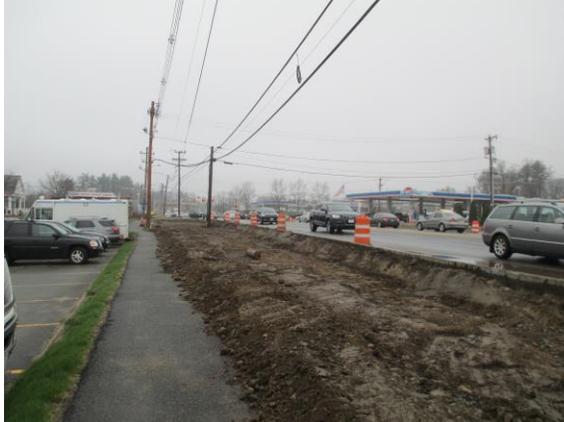
Signage, traffic cones and barriers were in place at the date of my visit. Work was largely focused on the southern shoulder of Littleton Road, and included stripping of loam, grading and other work related to the expansion of the pavement widening work. The following photos show the earth work noted on Thursday afternoon:

As can be seen in the photos, above, curbing remains in place and all work this week is located on the shoulder of the roadway. As the site work progresses, driveway entrances off of Littleton Road will also be cut, curbing removed and the new lane graded to allow for paving. Leaving the curb intact has minimized the deposition of silt or sediment on the roadway.

and drainage work is completed. As can be seen in the photos above, utility poles will need to be relocated for the work to continue.

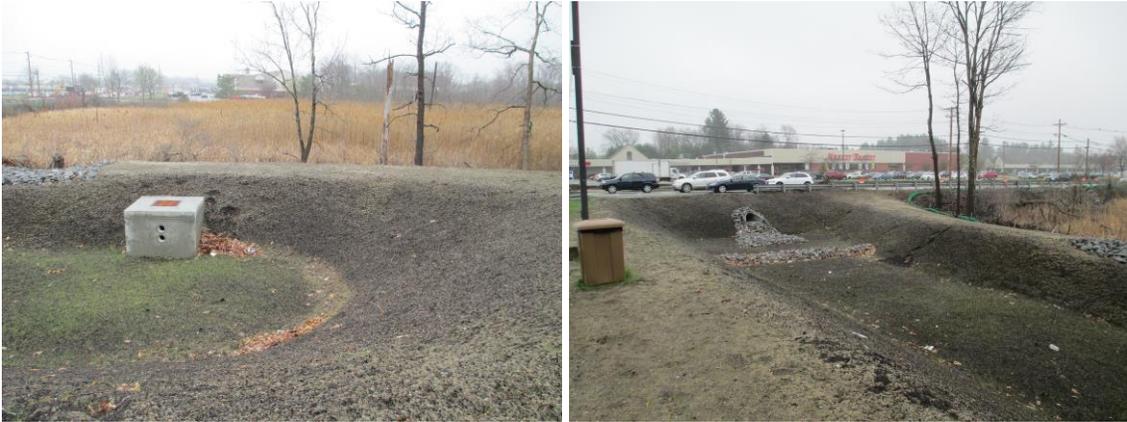
In early November of 2013, the contractor seeded the stormwater management basin located adjacent to the McDonalds parking lot. At my inspection this week, I noted that the seed is beginning to germinate. The slopes appear to have wintered well, and the tackifier has kept the bulk of the sediment on the slope. The following photos show this work area:

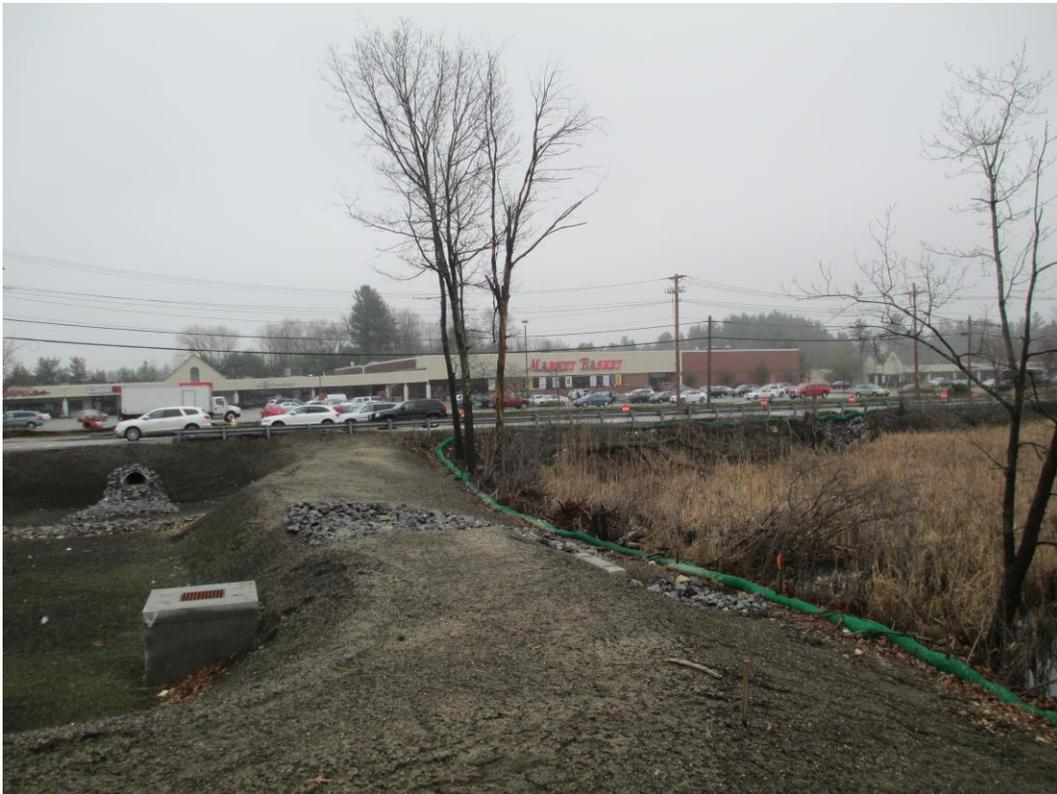
Erosion controls at the perimeter of this basin remain intact. There is no work ongoing along the northern shoulder at this time. The following photo shows some of the sediment barriers on the north side of Littleton Road:

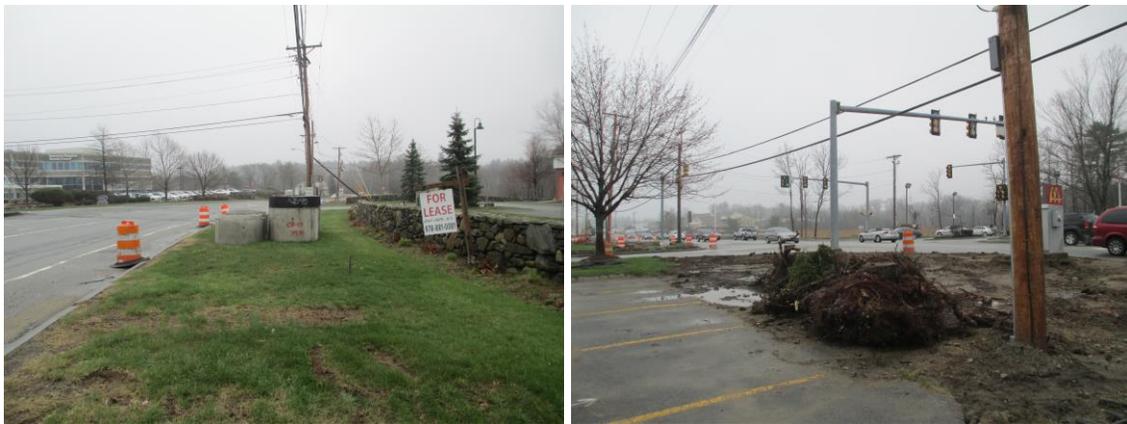
Staging of materials is being done from the shoulder of the roadway, and all equipment is being stored in non- jurisdictional areas. At the time of my inspection, the contractor was using staging areas along the northern and southern shoulders of Littleton Road. Temporary storage of earth materials was done within the work areas, but all earth materials will be hauled from the site:
