# Accessibility Audit

Prepared by Direct Access Consultancy LLC

June 2024

Westford Town Buildings  
Westford, MA 01886

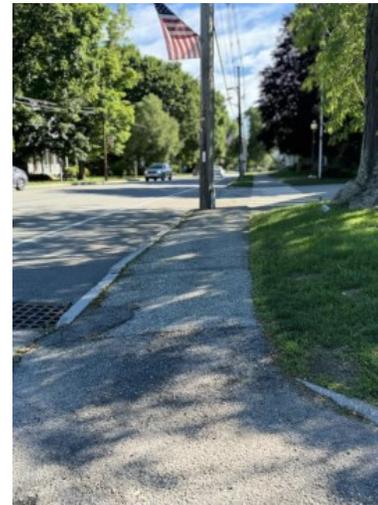
External: Path of Travel

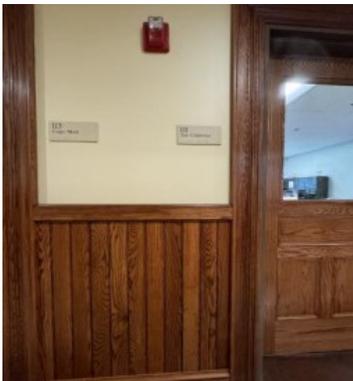
**Internal: Stairways**

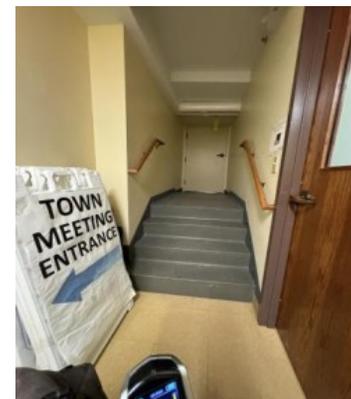
**Internal: Stairways**

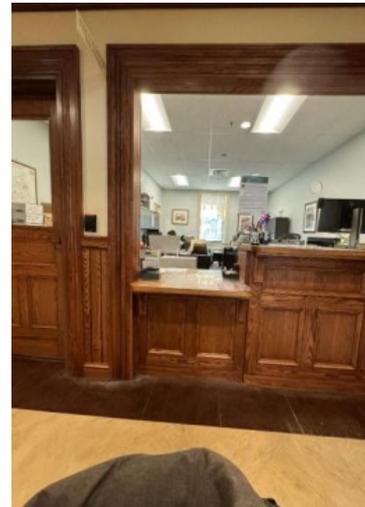
Internal: Service counters

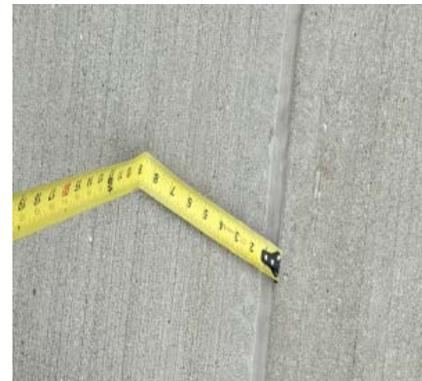
**External: Accessible Route**

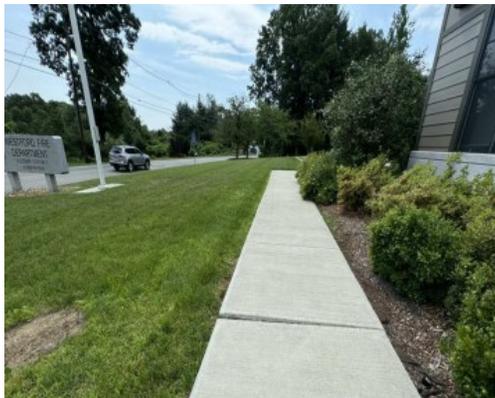
**External: Accessible Route**

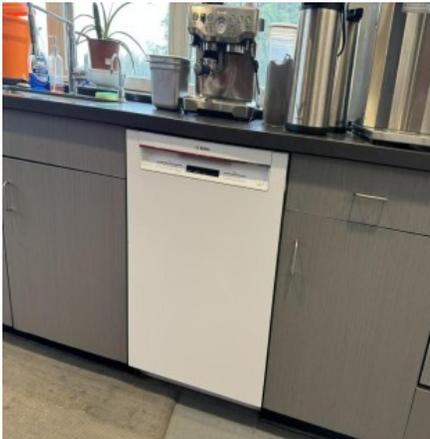
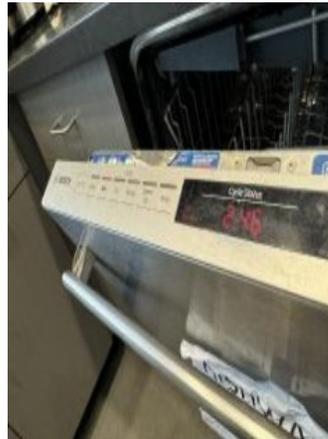
**Internal: Training Room**

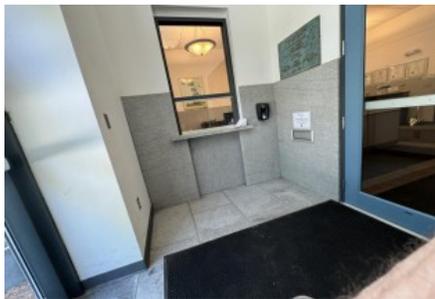
**Internal: Customer Service Area**

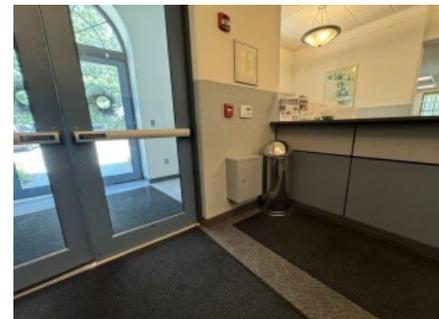
**Internal: Customer Service Area**

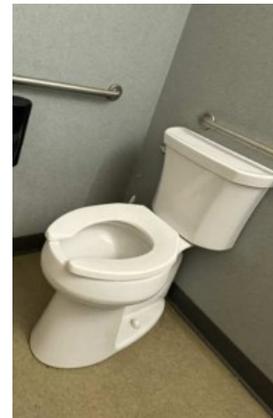
Internal: Accessible Restroom

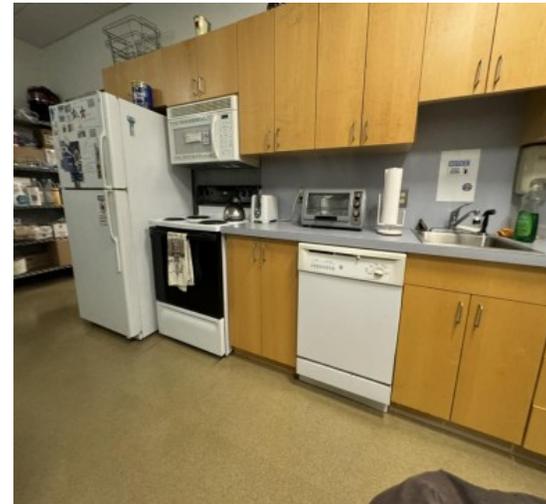
Internal: Kitchen

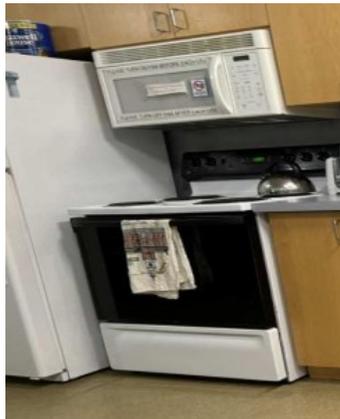
Internal: Kitchen

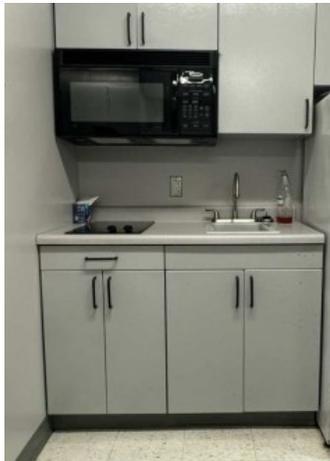
Internal: Lunchroom

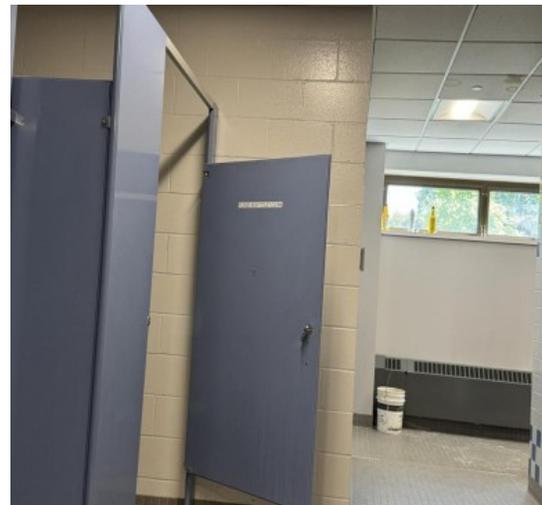
Internal: Men's locker room

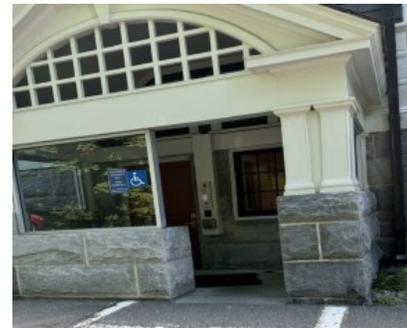
**External: Entrance Door**
