# Accessibility Audit

Prepared by Direct Access Consultancy LLC

September 2024

Westford Schools, Children's Centers & Museum

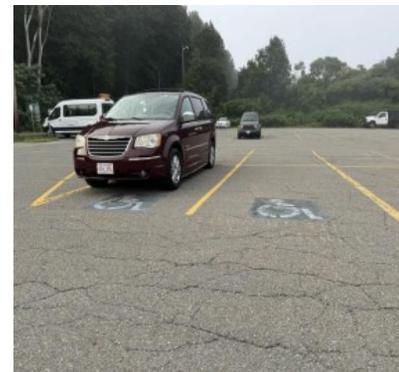
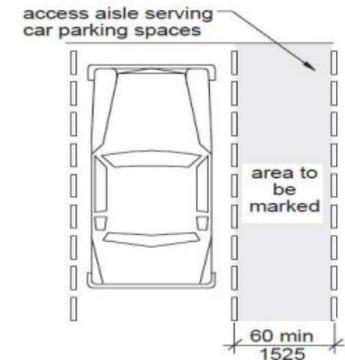
External: Pavement Degredation

High (1): Should be completed immediately. (Includes; Findings that have little or no cost, were in violation of the codes at the time of construction, or pose an imminent safety threat)

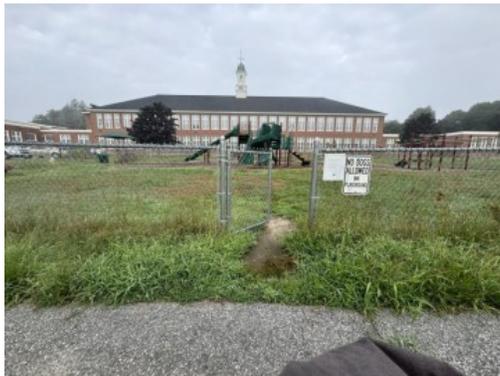
External: Playground

High (1): Should be completed immediately. (Includes; Findings that have little or no cost, were in violation of the codes at the time of construction, or pose an imminent safety threat)

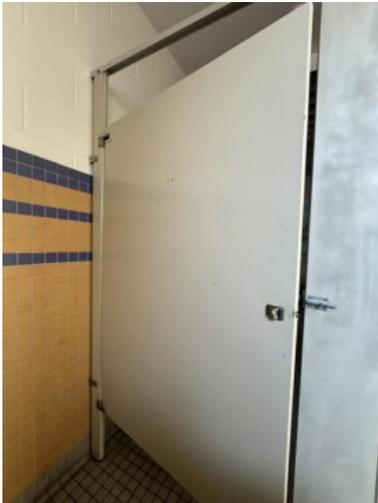
**Internal: signage**

High (1): Should be completed immediately. (Includes; Findings that have little or no cost, were in violation of the codes at the time of construction, or pose an imminent safety threat)

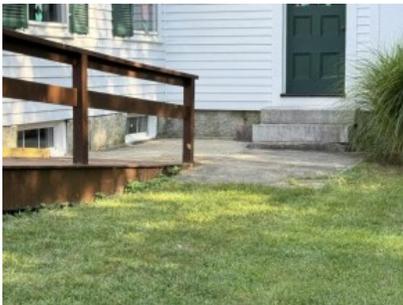
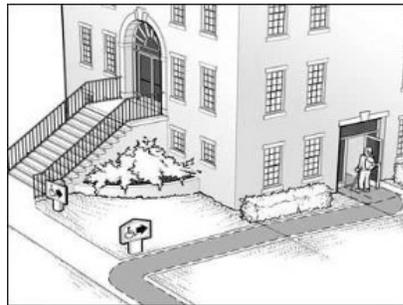
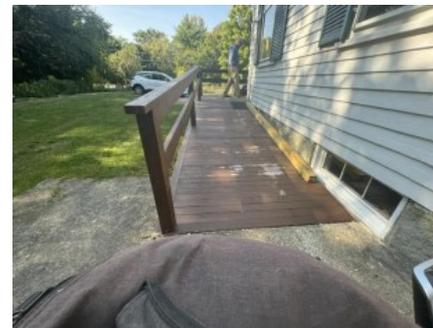
External: Ramp

High (1): Should be completed immediately. (Includes; Findings that have little or no cost, were in violation of the codes at the time of construction, or pose an imminent safety threat)

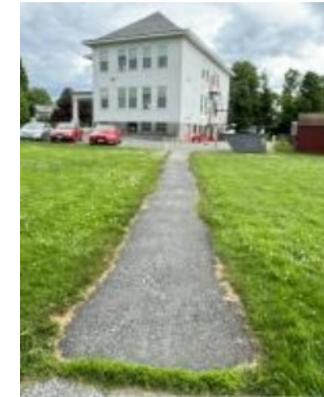
**Internal: Lack of an Accessible Entrance**

High (1): Should be completed immediately. (Includes; Findings that have little or no cost, were in violation of the codes at the time of construction, or pose an imminent safety threat)

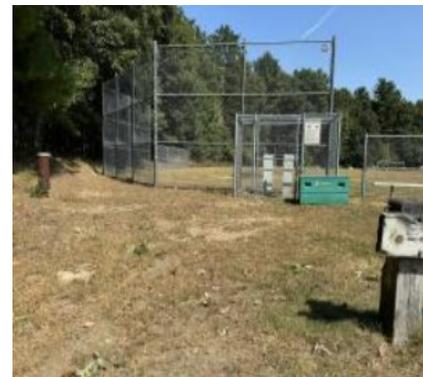
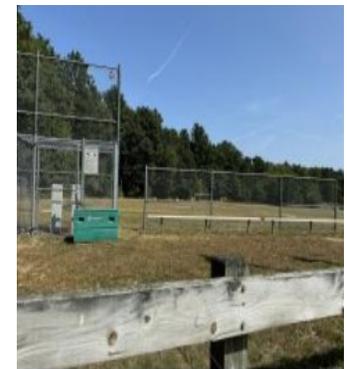
Side Field: Parking Lot

High (1): Should be completed immediately. (Includes; Findings that have little or no cost, were in violation of the codes at the time of construction, or pose an imminent safety threat)

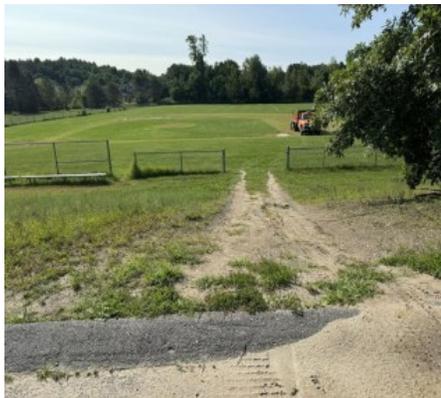
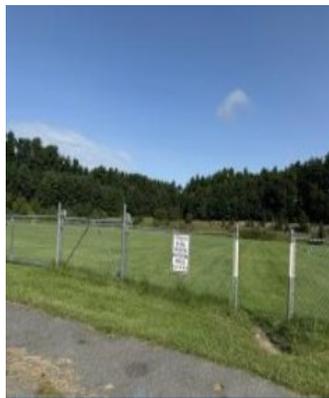
Side Field: Accessible Route

High (1): Should be completed immediately. (Includes; Findings that have little or no cost, were in violation of the codes at the time of construction, or pose an imminent safety threat)

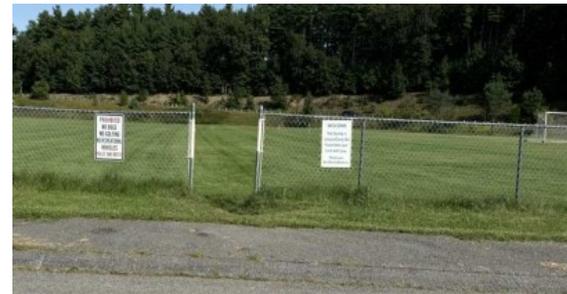
Side Field: Stairs

High (1): Should be completed immediately. (Includes; Findings that have little or no cost, were in violation of the codes at the time of construction, or pose an imminent safety threat)
