Town of Westford, Massachusetts

Pedestrian Network Inventory & Assessment

Preliminary Summary of Findings

Date: August 2025

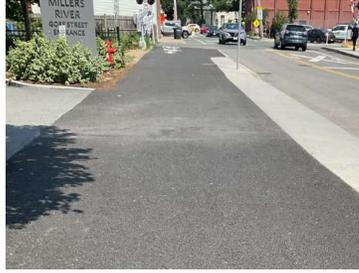
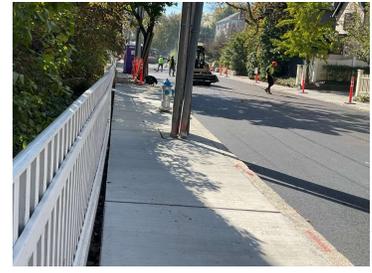
Good

- No surface distresses identified up to minor blemishes and deterioration observed on sidewalk.
- *Less than 10% of segment may need replacement.*

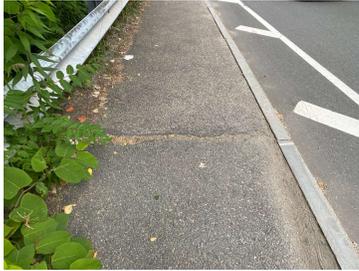
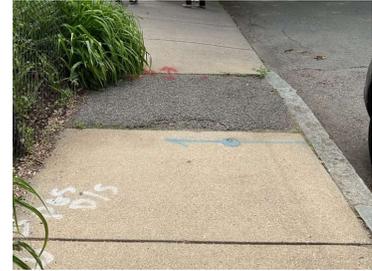
Fair

- Surface distresses developing, but provide minimal to no impedance
- *10% - 50% of segment may need replacement.*

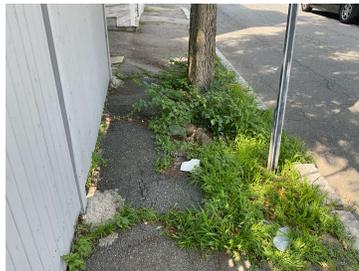
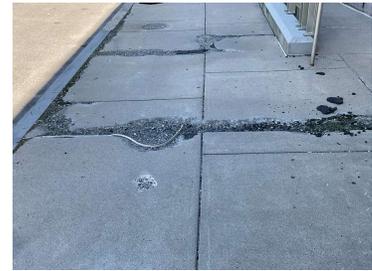
Poor

- Surface distresses and obstructions occur frequently, proving the sidewalk surface to be non-uniform and potentially unstable. (cracks, grass, depressions, bumps, patches, tree roots).
- *50% - 100% of segment may need replacement.*

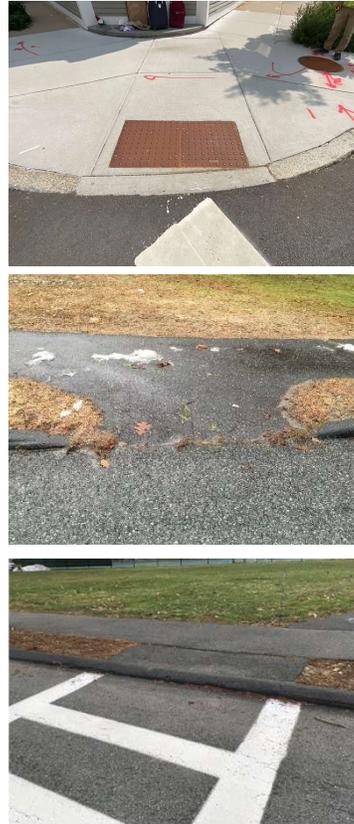
Representative Photographs

- Concrete surface typically meets the requirements for smooth, stable surface per PROWAG Section 3.2.6
- Detectable Warning Panel (DWP) meets the basic need per PROWAG Section 305

- Asphalt, brick or other material are less stable and are prone to shifting and deformity with exposure over time
- Lack of a DWP does not meet minimum standard

- Existing crossing missing one or more receiving ramps
