## FIELD REPORT No. 06

### ROUDENBUSH COMMUNITY CENTER REHABILITATION

**DATE/TIME:** Mar 1, 2018 – Apr 4, 2018 (Project Meetings on Mar 7, 21, 28 & Apr 4)  
**PURPOSE:** Construction Progress Summary  
**PRESENT:** Don Mills, Architect / Mills Whitaker Architects LLC  
Ron Marsden, Architect's Site Rep (Clerk) / Delmont Construction Services  
Bill Kenison, Owner's Project Manager / Town of Westford  
Jeanne Roberts, Permanent Town Building Committee / Town of Westford  
Steve Salemi, Project Manager / NELCO Worldwide  
Stevan Gauthier, Project Superintendent / NELCO Worldwide  
Alexander Castelluccio, Project Administrator / NELCO Worldwide (3/28)  
Shawn Chamberlin, Safety Officer / NELCO Worldwide (3/28 & 4/4)  
Greg Nowak, Structural Designer / Structures North Consulting (3/7)

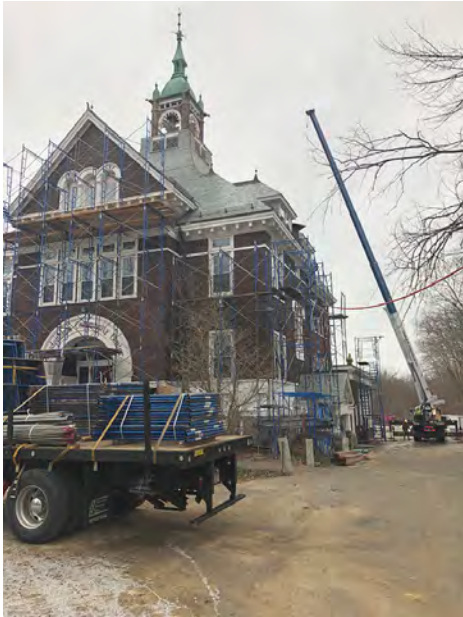
180307-IMG\_8034.jpg

*Commencement of Scaffolding Installation at Exterior of the Building*

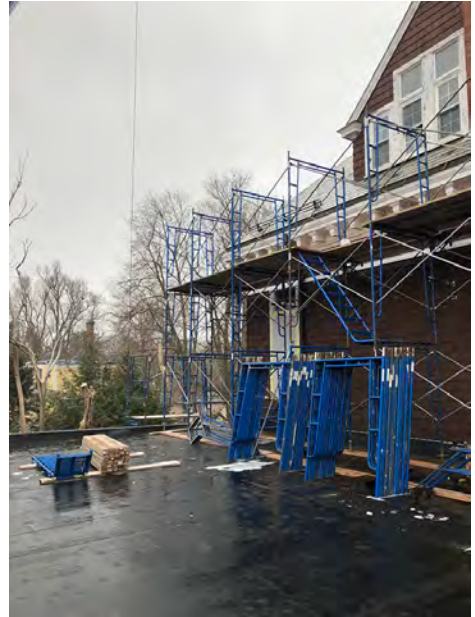
180307-IMG\_8053.jpg

*Scaffolding Delivery to Rear Facade at Gym Roof*

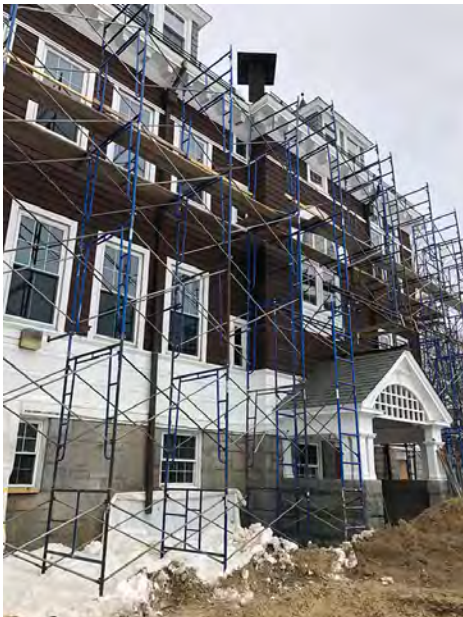
180321-IMG\_8128.jpg

*Scaffolding Installation at East Facade*

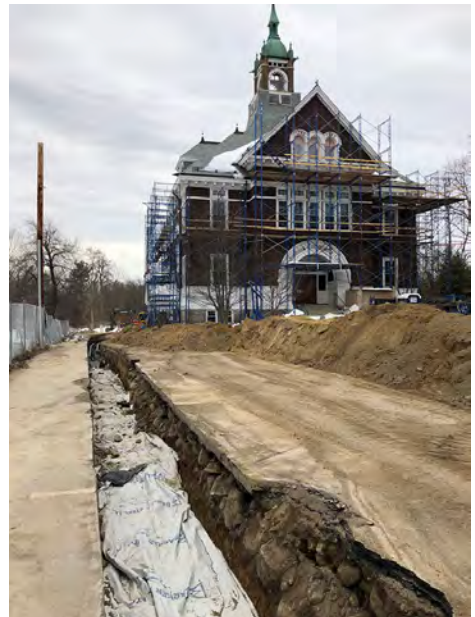
180321-IMG\_8131.jpg

*Trenching for Electrical Service at Exit Drive*

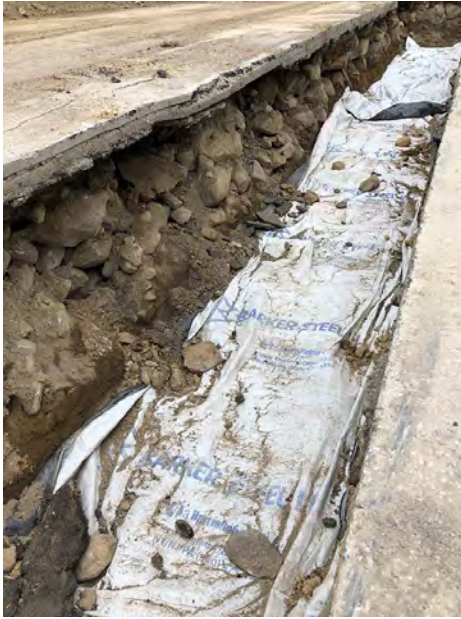
180321-IMG\_8130.jpg

*Detail of Excavation Trench at Exit Drive  
Looking Toward Main Street*

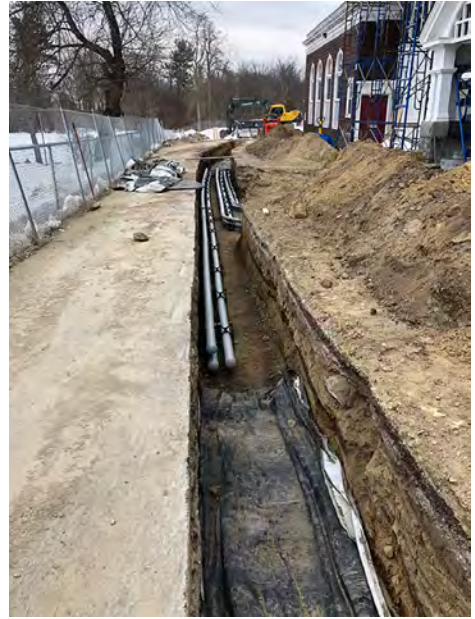
180321-IMG\_8129.jpg

*Electrical Service Trench with Conduits in Progress*

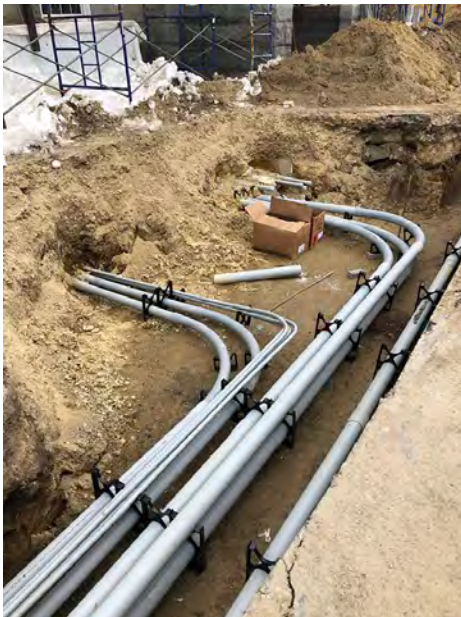
180321-IMG\_8127.jpg

*Conduit Feeds into Building from Transformer and  
Emergency Generator to Electrical Room*

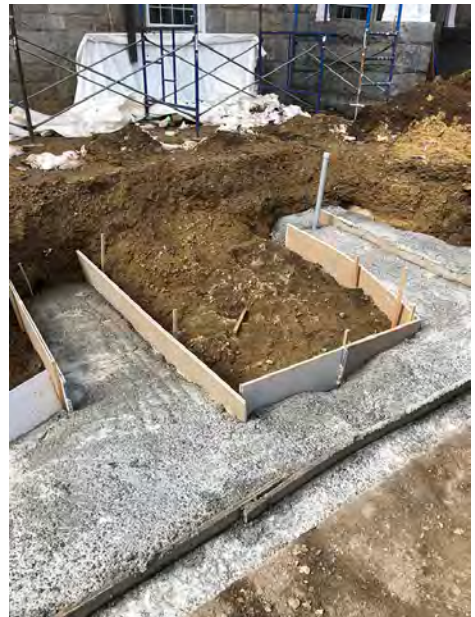
180328-IMG\_8192.jpg

*Concrete Coverage in Place at Conduit  
Feeds into the Building*

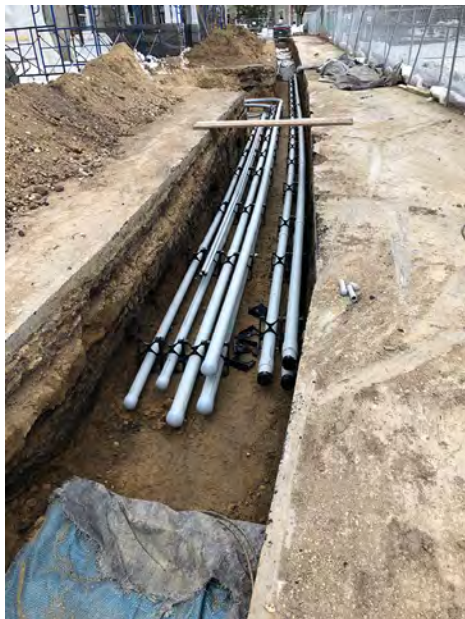
180321-IMG\_8126.jpg

*Conduit Installation in Progress*

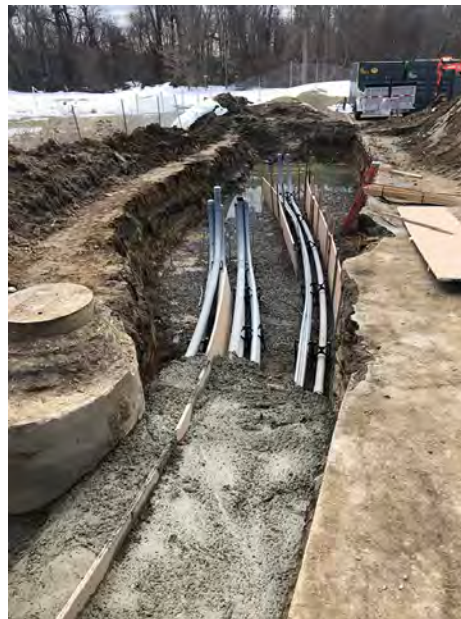
180328-IMG\_8190.jpg

*Concrete Coverage in Process at Conduit Trench*

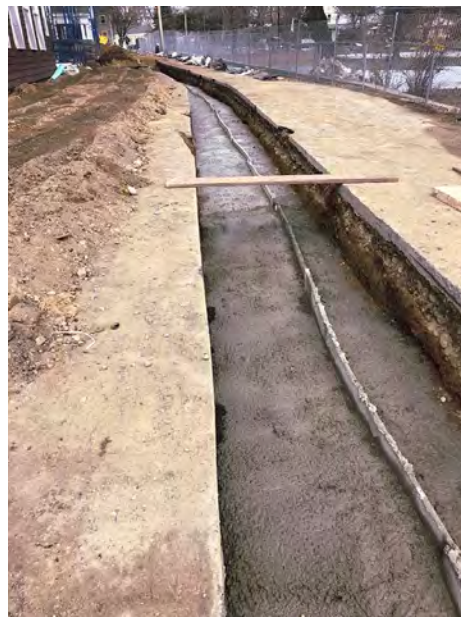
180328-IMG\_8191.jpg

*Concrete Coverage over Conduits Completed*

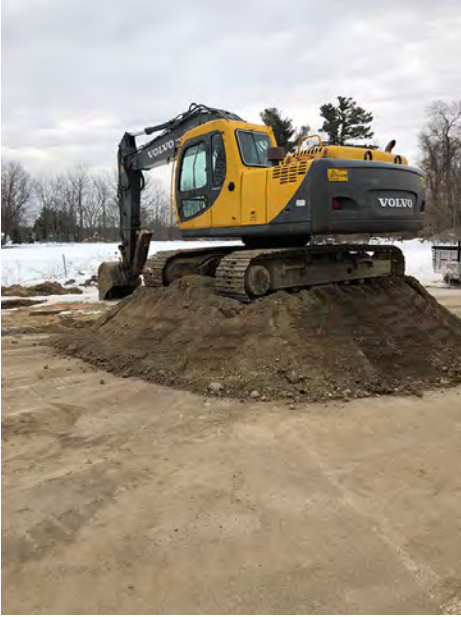
180321-IMG\_8132.jpg

*Excavator in Position for Preparation of Grading for Placement of Transformer and Generator Pads*

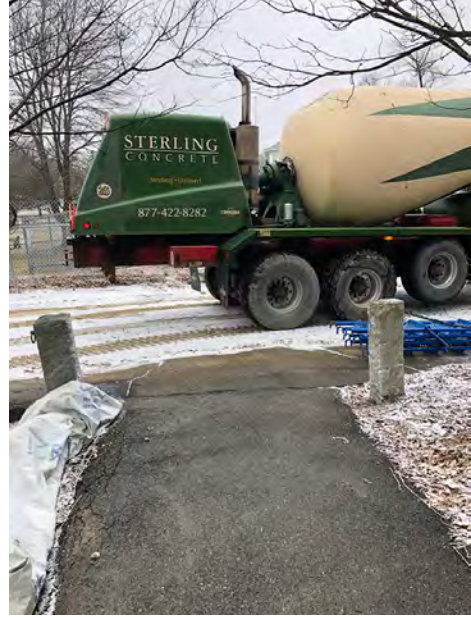
180307-IMG\_8055.jpg

*Concrete Delivery for Placement into East Half of Reconfigured Basement Level*

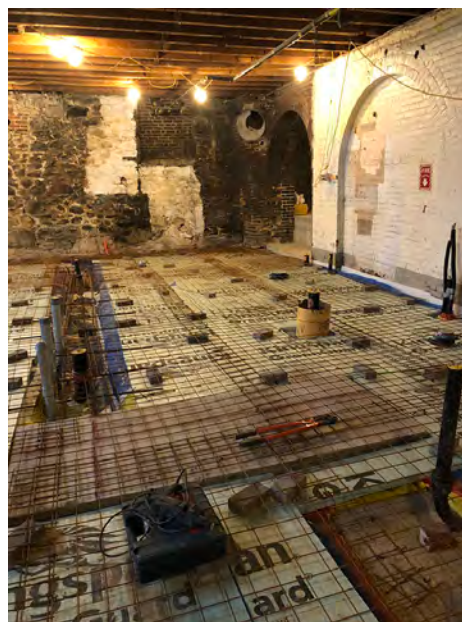
180307-IMG\_8044.jpg

*Typical Rebar and Rigid Insulation Prior to Placement of Concrete Slab*

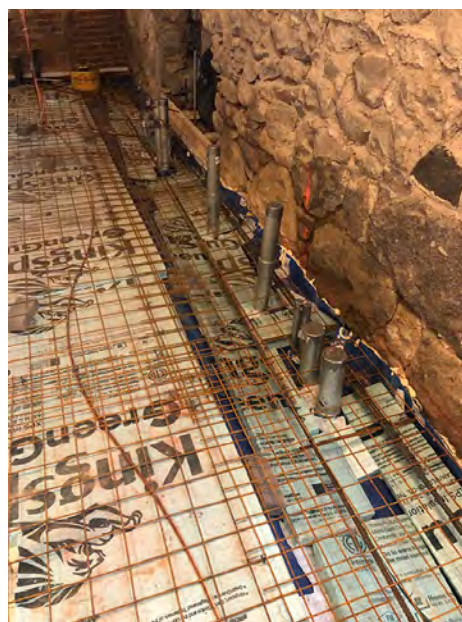
180307-IMG\_8040.jpg

*East Wall of Electrical Room with Stubs of Underground Conduits*

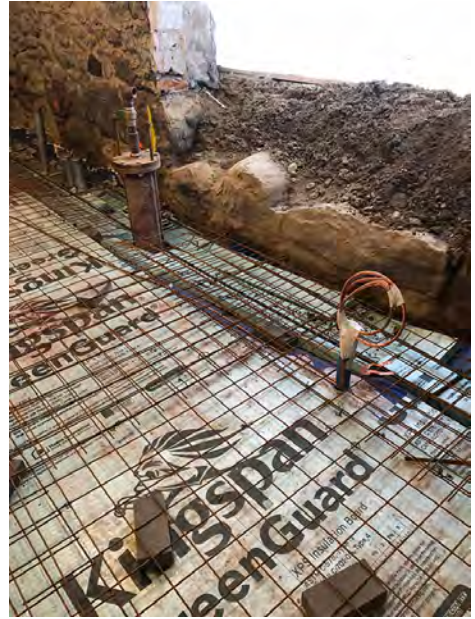
180307-IMG\_8039.jpg

*Water Piping for Fire Suppression System and  
Domestic Water Supply System*

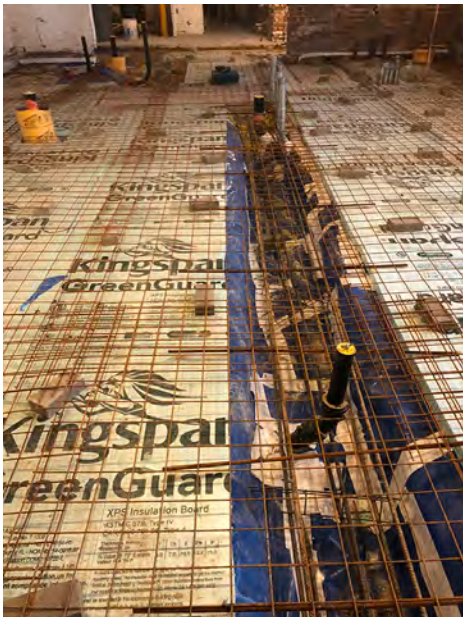
180307-IMG\_8038.jpg

*Deeper Trench for Added Bearing Wall to  
Shorten Original Joist Span at First Floor Above*

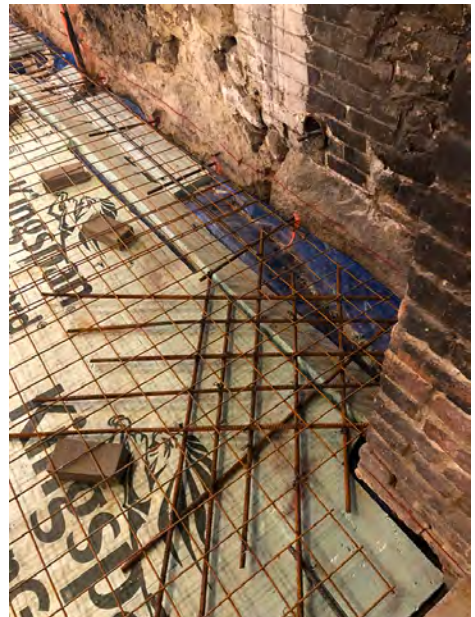
180307-IMG\_8036.jpg

*Typical Reinforcement at Corner of Slab*

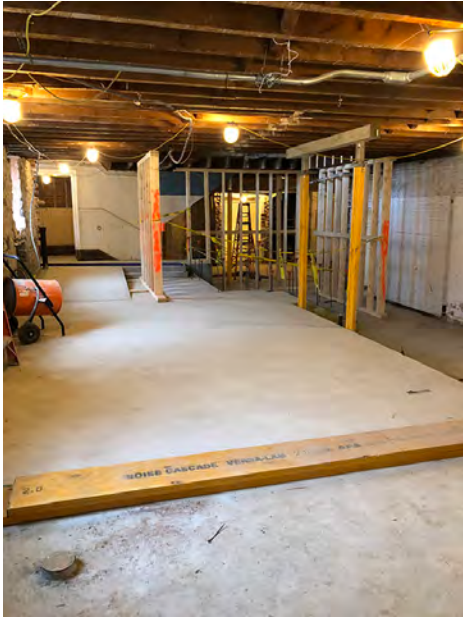
180321-IMG\_8134.jpg

*Lower Lobby Slab with  
Shoring at Elevator Hoistway Beyond*

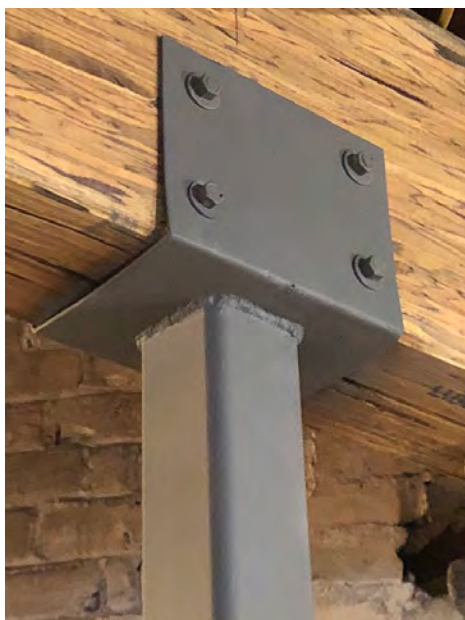
180328-IMG\_8187.jpg

*Tube Steel Post and Cap Supporting Added Beam in Basement at Facility Manager's Office*

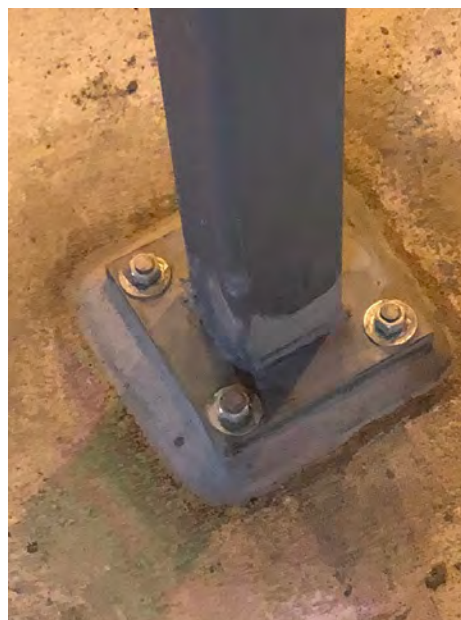
180328-IMG\_8184.jpg

*Tube Steel Post and Base at Facility Manager's Office*

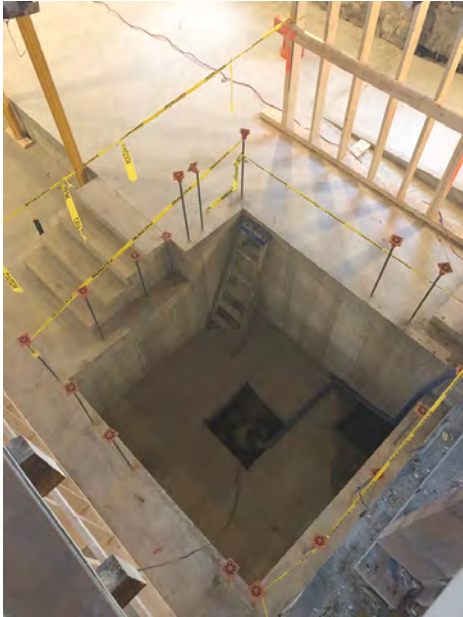
180307-IMG\_8046.jpg

*Elevator Pit at Lower Lobby*

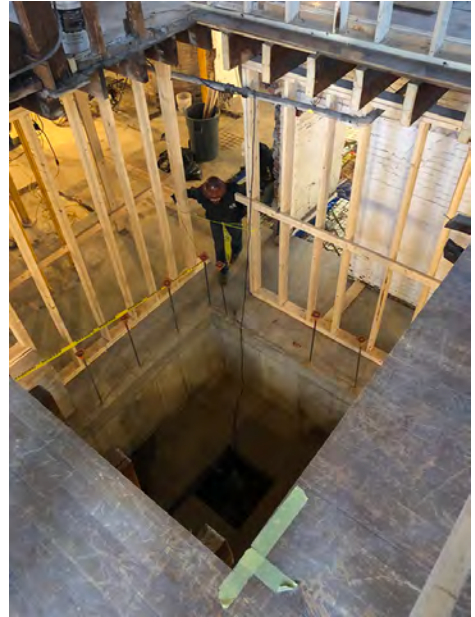
180307-IMG\_8050.jpg

*Northeasterly View of Elevator Pit and Adjacent Shoring*

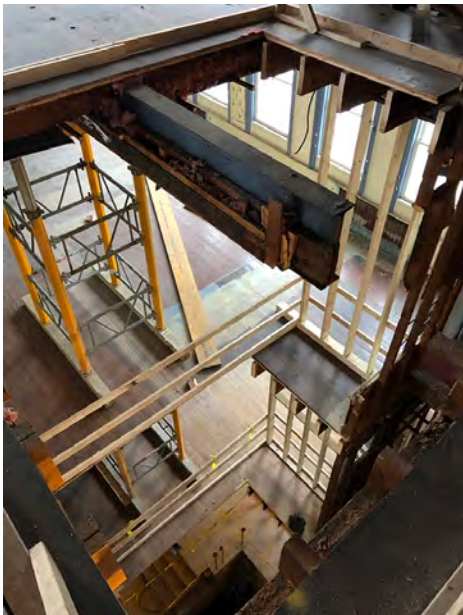
180321-IMG\_8140.jpg

- 06.2 Floor openings for the elevator hoistway have been provided at each level. Shoring and guardrails have been installed adjacent to and around the openings. CMU and reinforcing rods have been delivered to the site. Submittals for grouting of cores needs to be provided. UTS will review reinforcing and test grout.

*Opening in Third Floor for Elevator Hoistway*

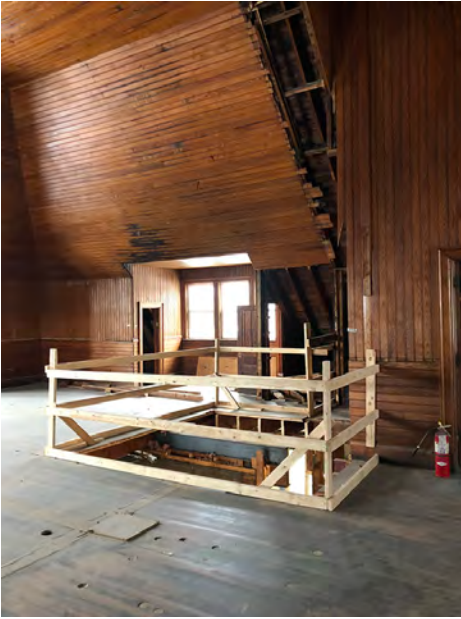
180321-IMG\_8139.jpg

*Third Floor Guardrails and Toe Kick Boards at Elevator Hoistway Opening*

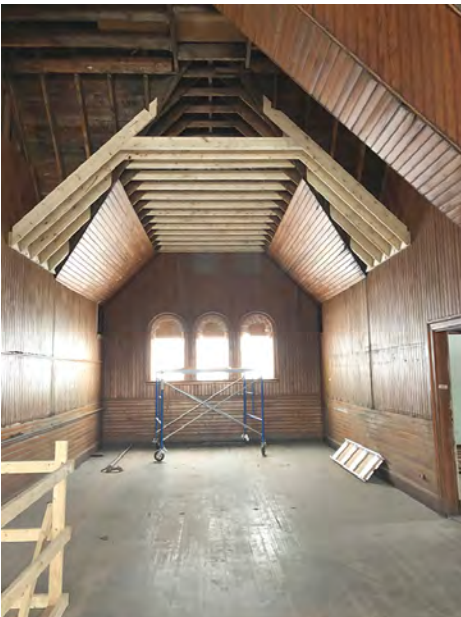
180321-IMG\_8142.jpg

*Collar Tie Framing at Height of Former Ductwork Frames Ceiling Shape of Seminar Room*

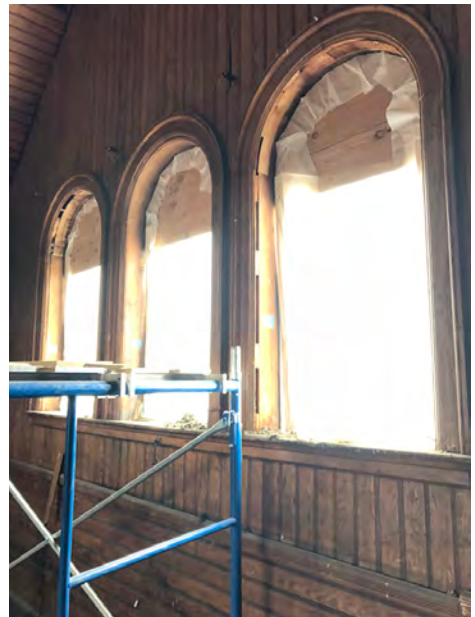
180321-IMG\_8143.jpg

*Tripartite Windows at Front Facade of Third Floor Removed Offsite for Repair and Restoration*
