WATER DEPARTMENT OFFICES

60 Forge Village Road

Year Constructed: 2003
Year of Renovation/Addition: NONE
Building Type: B, F-2
Construction Type: III B
Fire sprinklers: No
Total Floor Area: 16,000 SF
Floors: First
Assessor Lot # 025 0010 0000

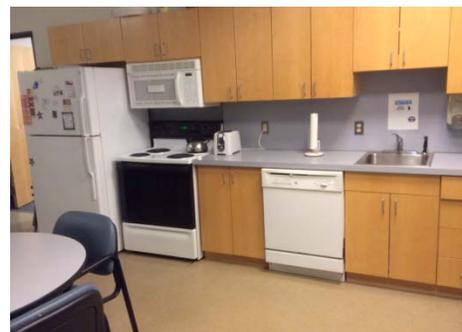
Kitchen cabinets, appliances and sink are not in conformance with ADA. Sink needs to be shallower with knee space beneath. Range does not have controls at front and microwave is too high. Counters should be no higher than 34". It is recommended that initially the sink and it's cabinet be replaced to comply with ADA.

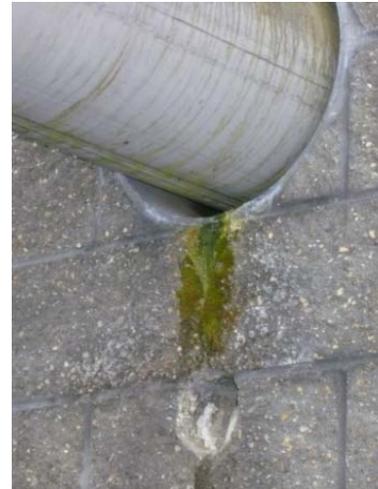
- 3 Non-shrink leveling grout has cracked and requires replacement.
- 3 Water is collecting at thimble through wall allowing moss to grow. Some concrete masonry has broken off. Clean moss from wall and patch masonry.
- 3 Miscellaneous roof repairs are required including shingle repair, repairs to dormers, exhaust vents (2), Pipe penetrations (5), lightning rod repairs, and gutter system estimated at \$2,500. in the Roof Management Consultants, Inc's report dated November 14, 2013

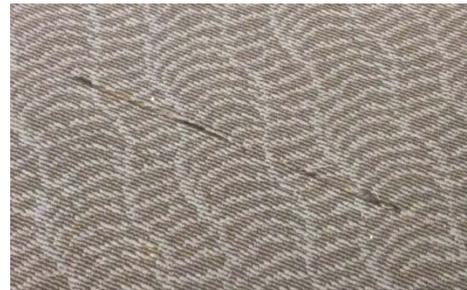
- 3 There are a number of carpet seams that have started to fail. These should be repaired to avoid continuous growth of the open seams.

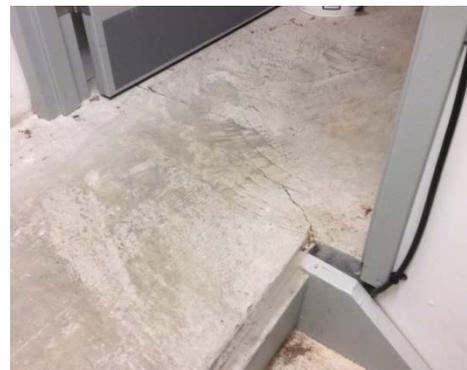
- A stair extends into the door opening and there is a gap between the stringer and the floor. There does not appear to be a simple solution to this problem. It is suggested that warning markings be applied to the floor at the top of the stair and the gap between the stringer and floor be filled.
