**Annual Report**  
2021 Management Program  
Westford Ponds  
Westford, MA

Prepared by: SÖLitude Lake Management  
590 Lake Street  
Shrewsbury, MA 01545

Prepared for: Town of Westford  
c/o Rae Dick & Matthew Salem  
55 Main Street  
Westford, MA 01886

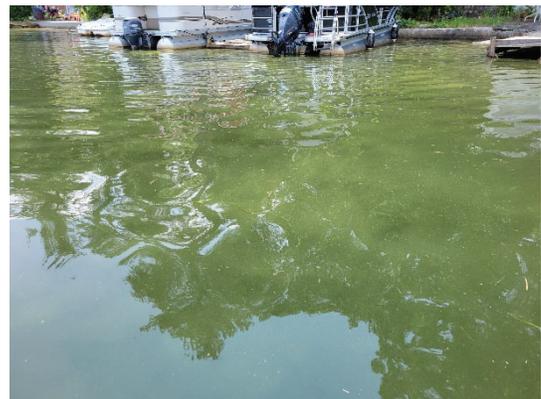
*Area of dense phytoplankton and filamentous algal growth at Long Sought-for Pond.*

Of note, some areas of dense phytoplankton growth were noted at Long Sought-for Pond in 2021, often mixed with filamentous algae. The bloom appeared to be concentrated in sheltered coves and was not readily visible elsewhere. Based on a qualitative analysis of a single grab sample taken from the eastern shoreline, the phytoplankton in this area appeared to be dominated by cyanobacteria (*Microcystis* sp.).

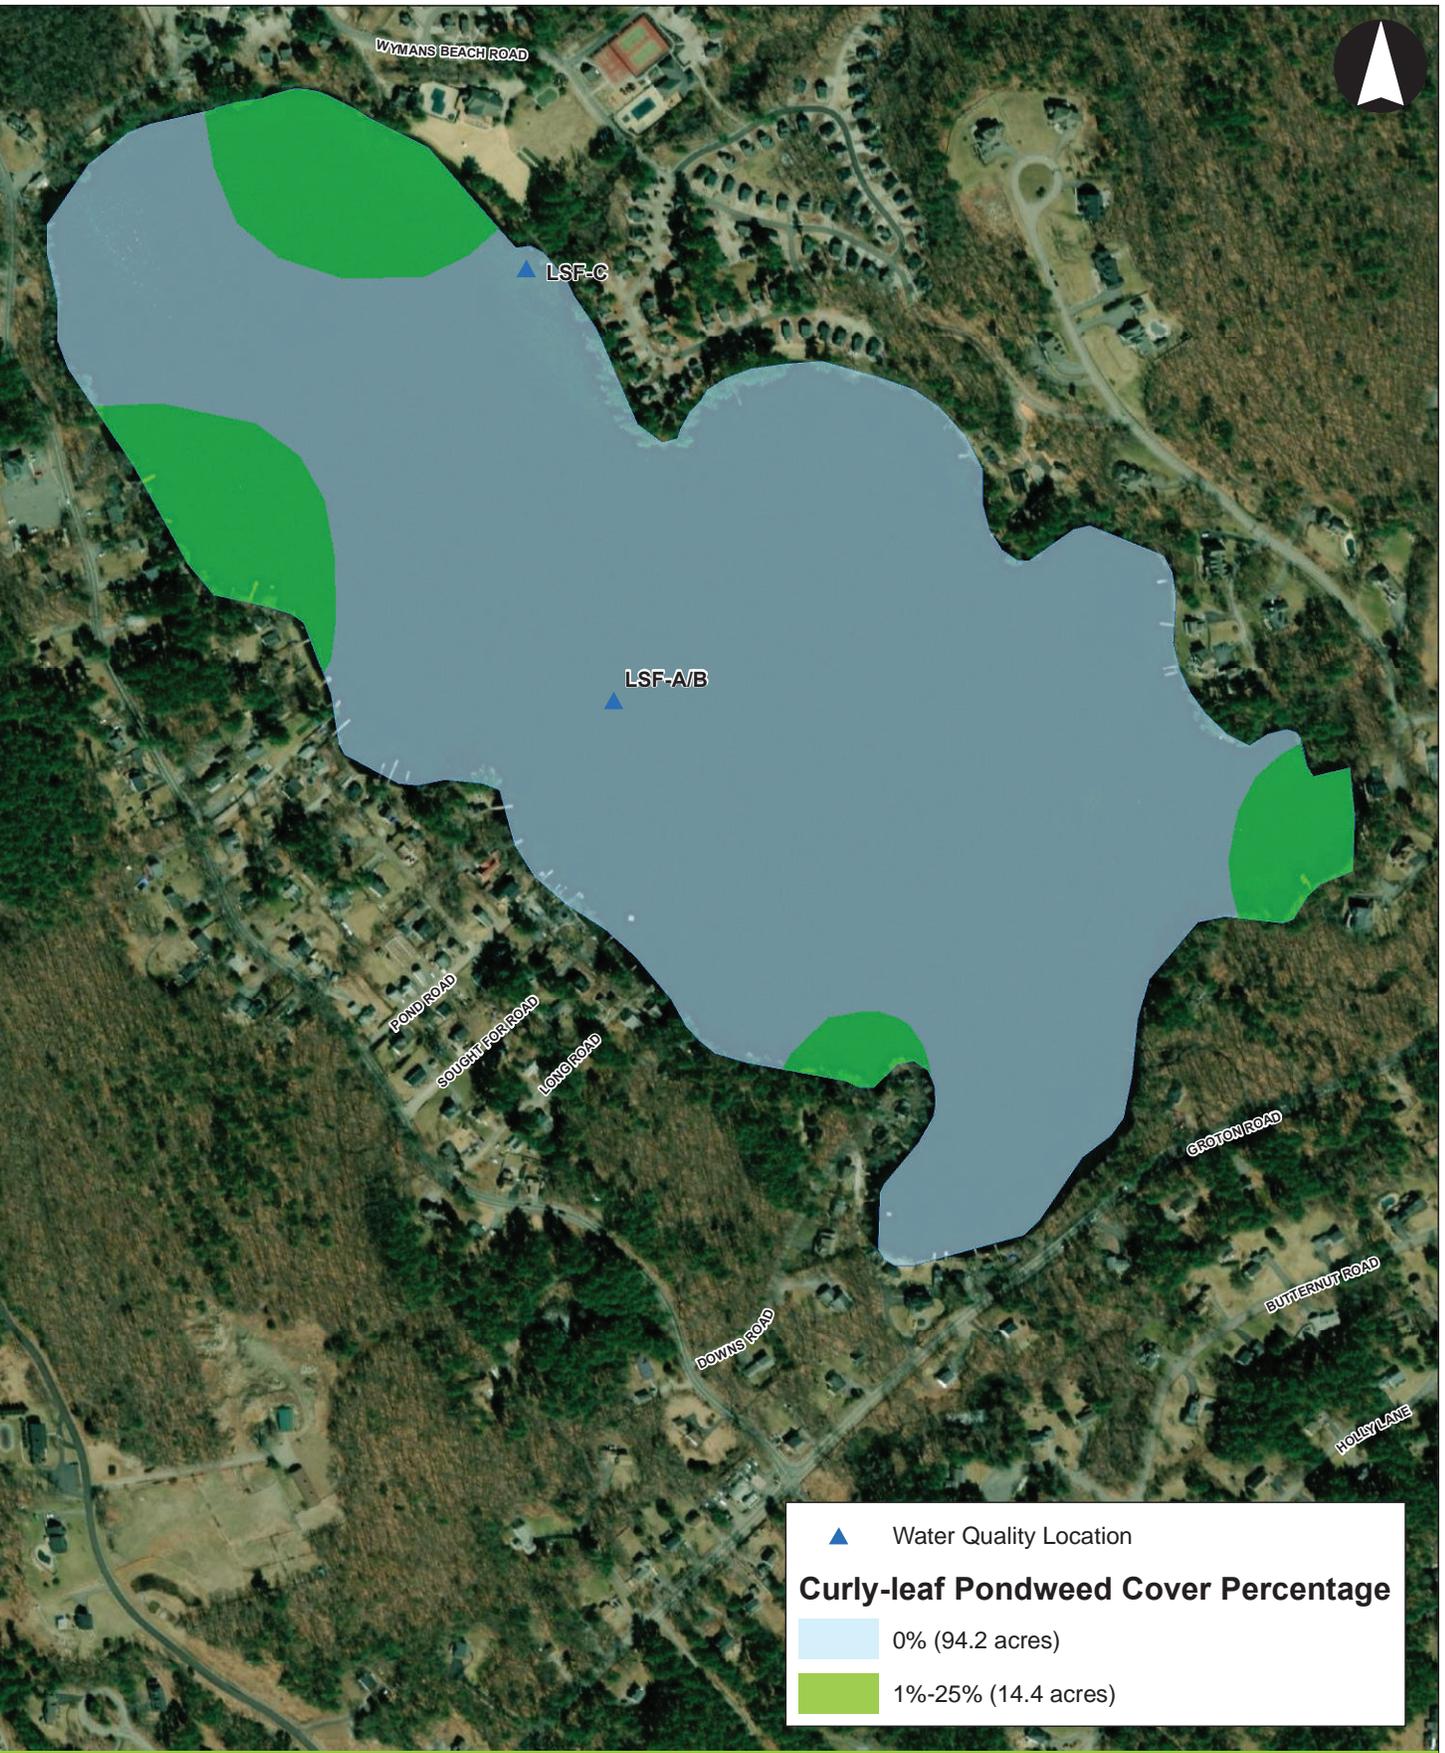
Aquatic invasive curly-leaf pondweed covered approximately 14 acres during the 2021 pre-treatment survey (Figure 1). Beds were generally of low density in all areas where observed.

**Curly-leaf Pondweed Cover Percentage**

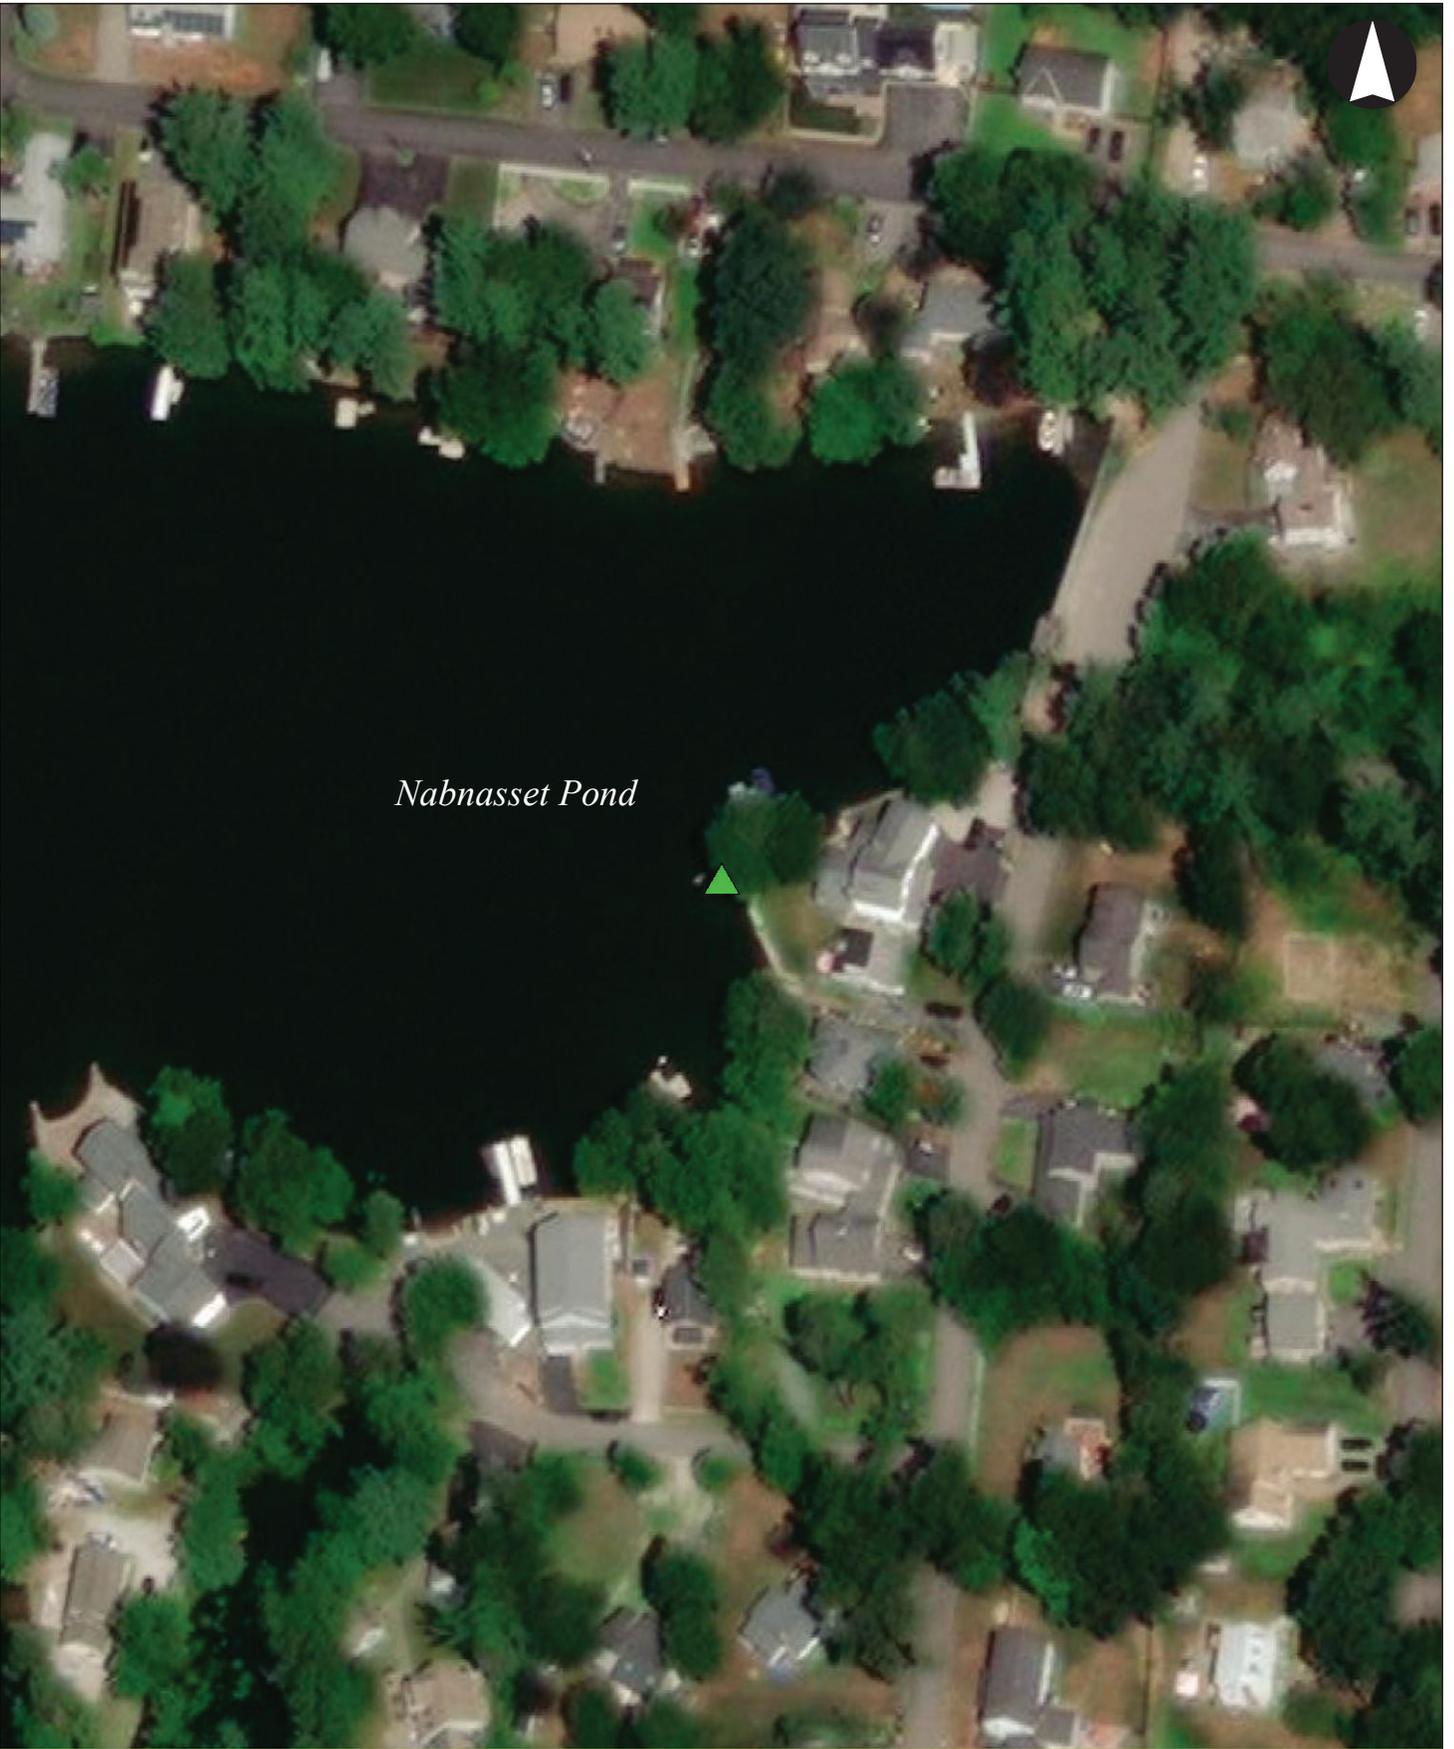
*Nabnasset Pond*

Native water celery (*Vallisneria americana*) was observed growing in sparse to patchy beds along much of the shoreline of Nabnasset Lake during the 2021 post-treatment survey (Figure 4). This species covered approximately 12 acres, which is less than half the total area covered during recent surveys in July 2021 and autumn 2020.

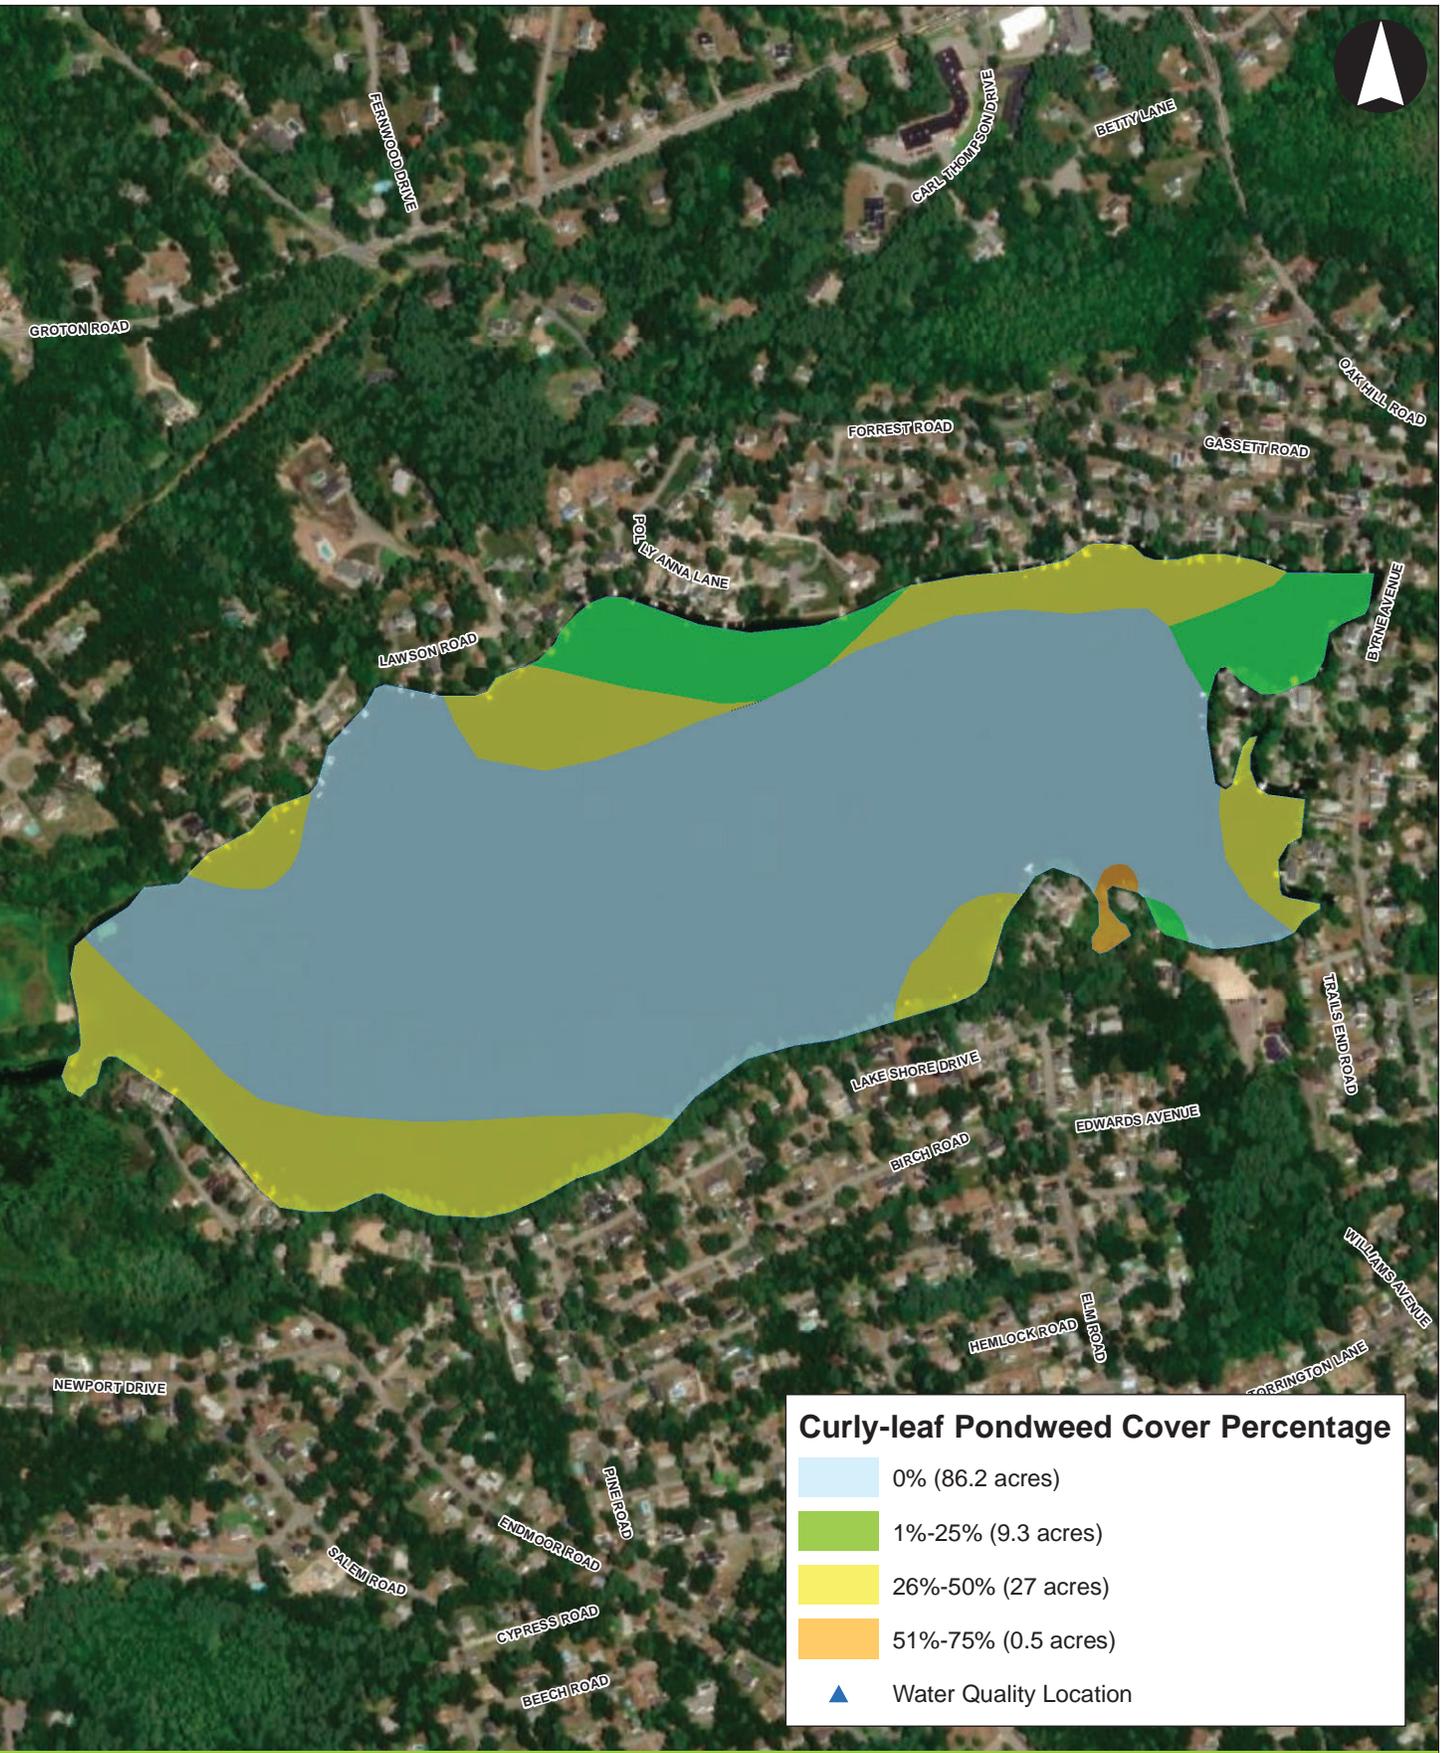
Additionally, aquatic invasive curly-leaf pondweed covered approximately 37 acres during the 2021 pre-treatment survey (Figure 4). This species was widespread but only found at low to moderate densities within most of the mapped area.

**Curly-leaf Pondweed Cover Percentage**

Light Blue	0% (86.2 acres)
Green	1%-25% (9.3 acres)
Yellow	26%-50% (27 acres)
Orange	51%-75% (0.5 acres)
Blue Triangle	Water Quality Location

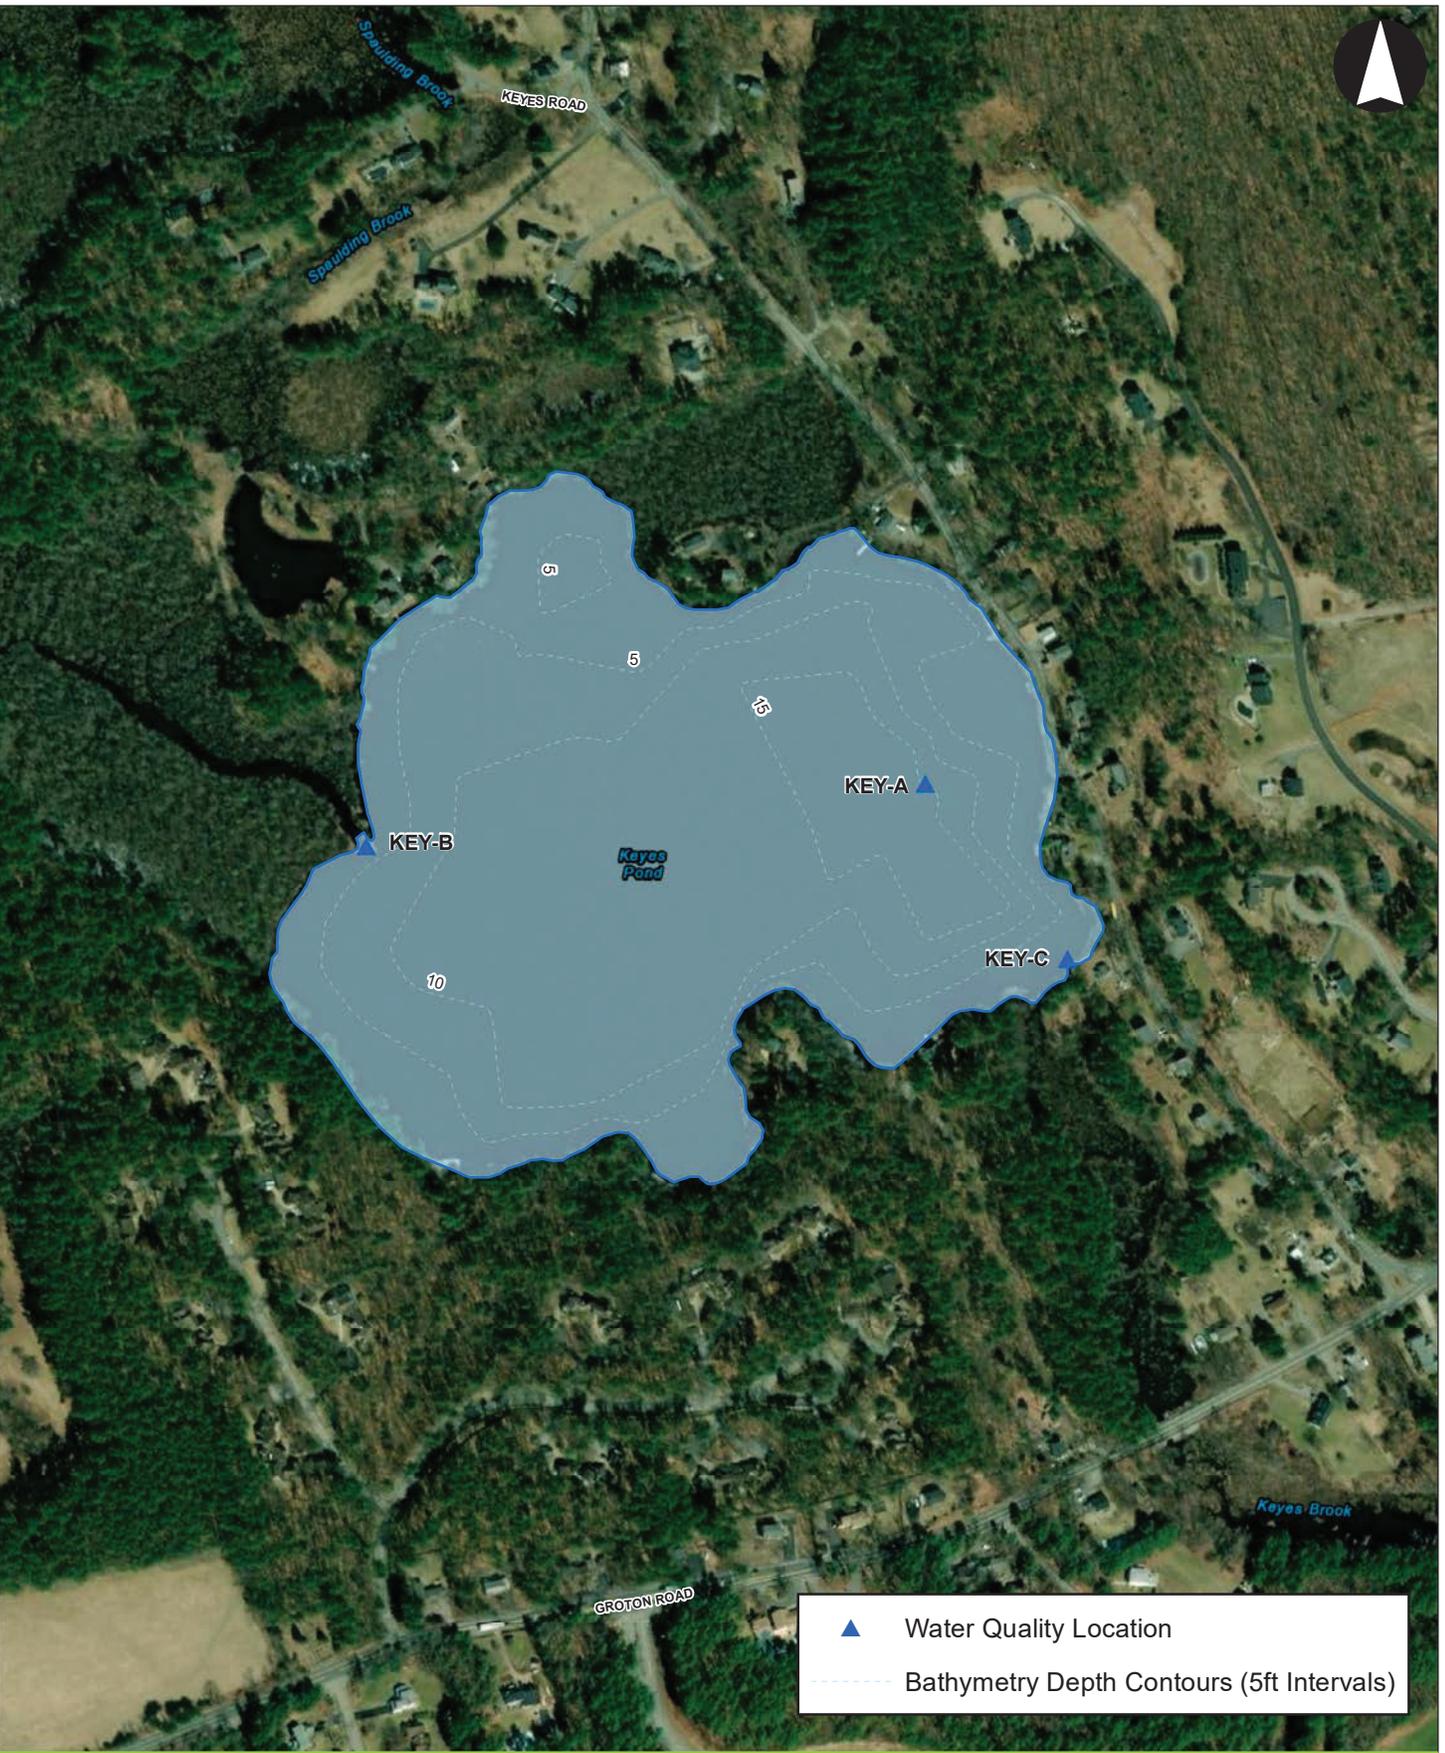
Figure 1

Seven species of native plants were observed in Keyes pond during the 2021 post-treatment survey. No aquatic invasive plants were observed (Figure 1). Of note, invasive variable-leaf milfoil (*Myriophyllum heterophyllum*) has not been observed during ESS's surveys at Keyes Pond since pre-treatment mapping in 2017.

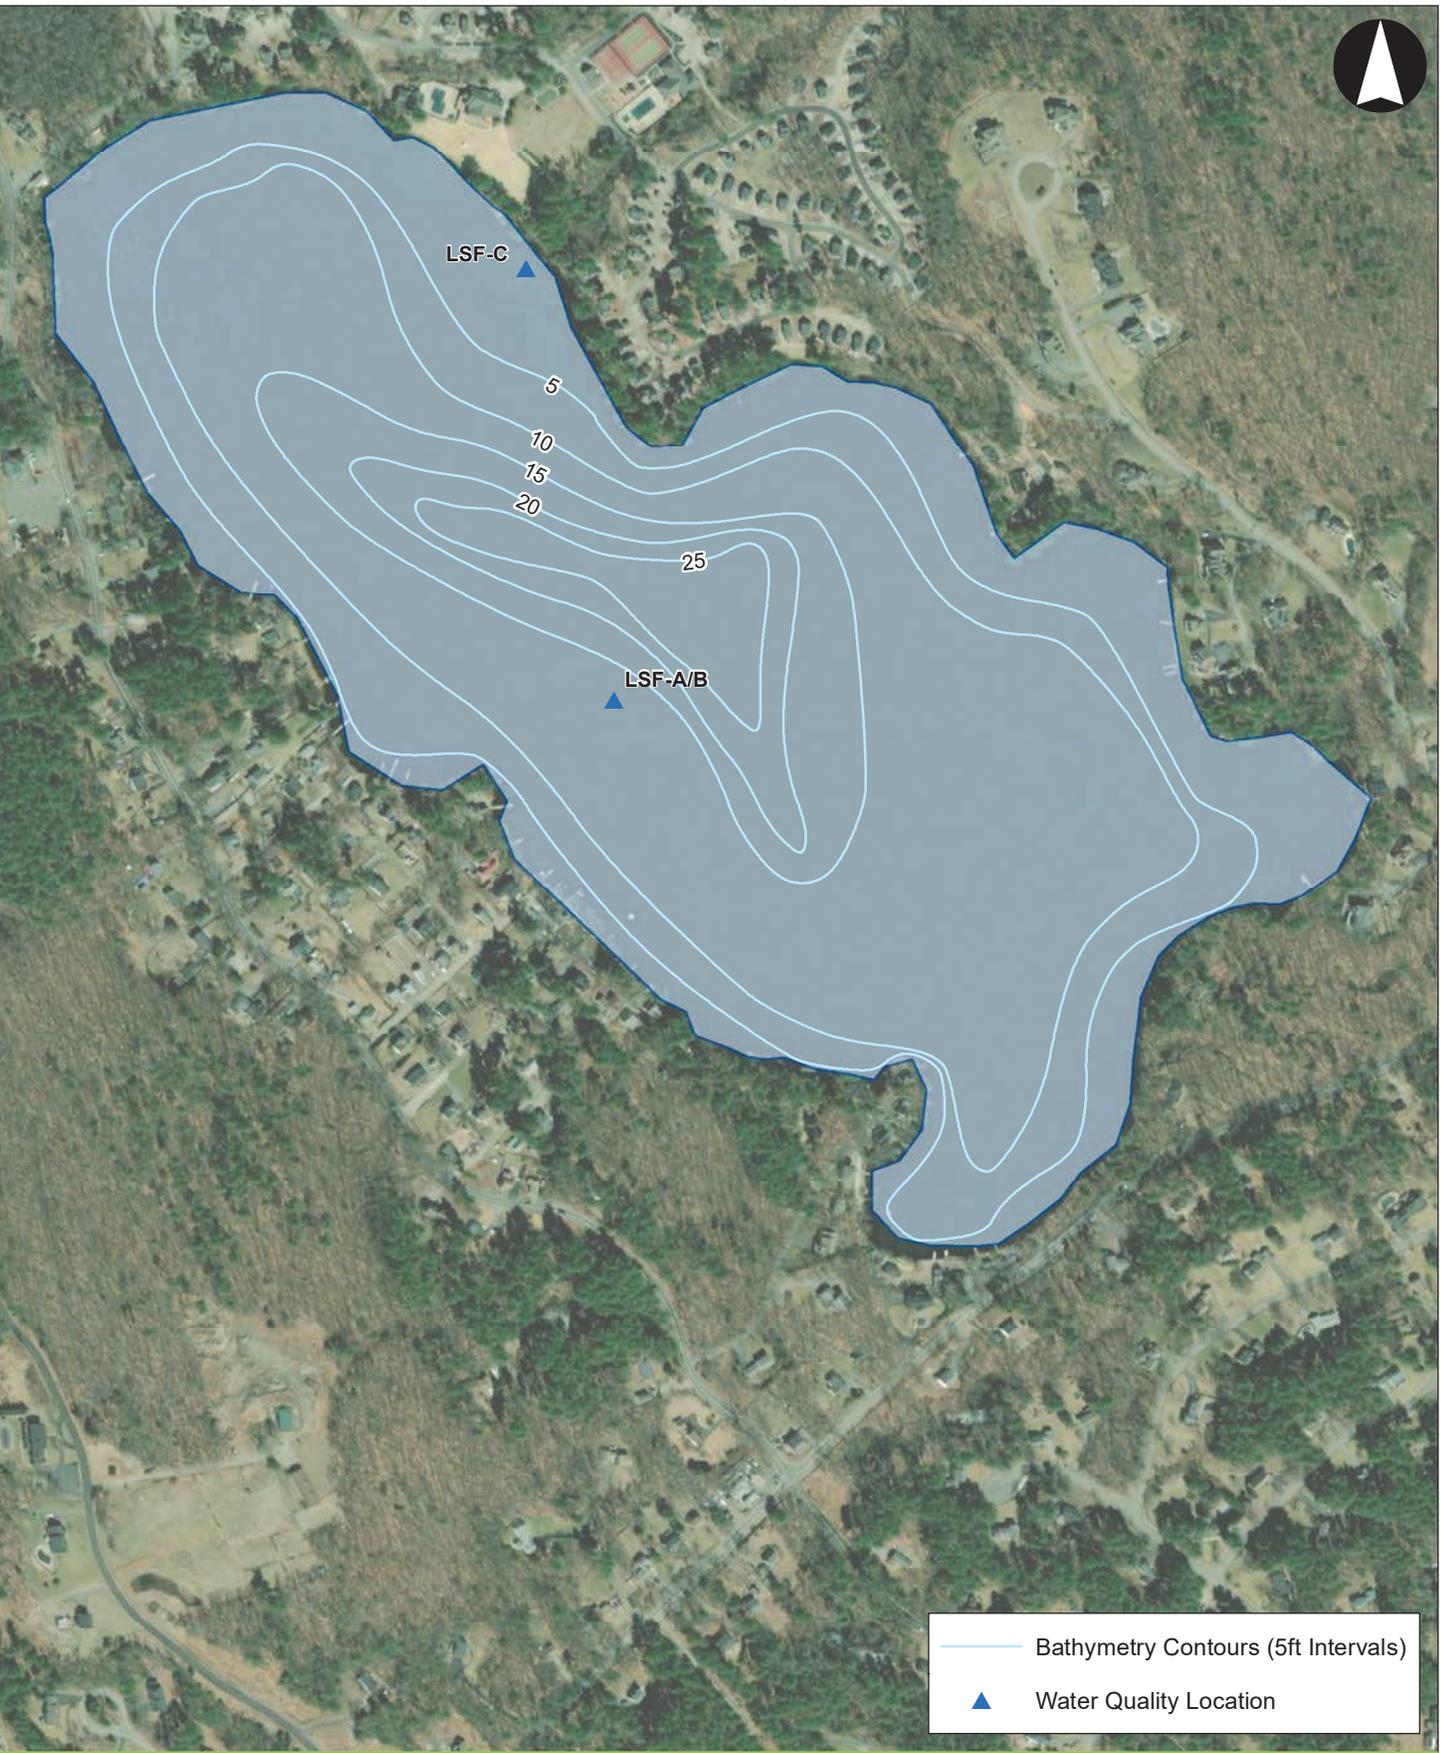
**Figure 2**

Eleven species of aquatic plants were observed in Long Sought-for Pond during the 2021 post-treatment survey. However, no aquatic invasive plants were observed (Figure 2).

Flat-stem pondweed (*Potamogeton zosteriformis*), a management target at Long Sought-for Pond, was also not observed during the 2021 post-treatment survey. However, this species was observed as expired biomass, presumably having succumbed to treatments applied earlier in the season.

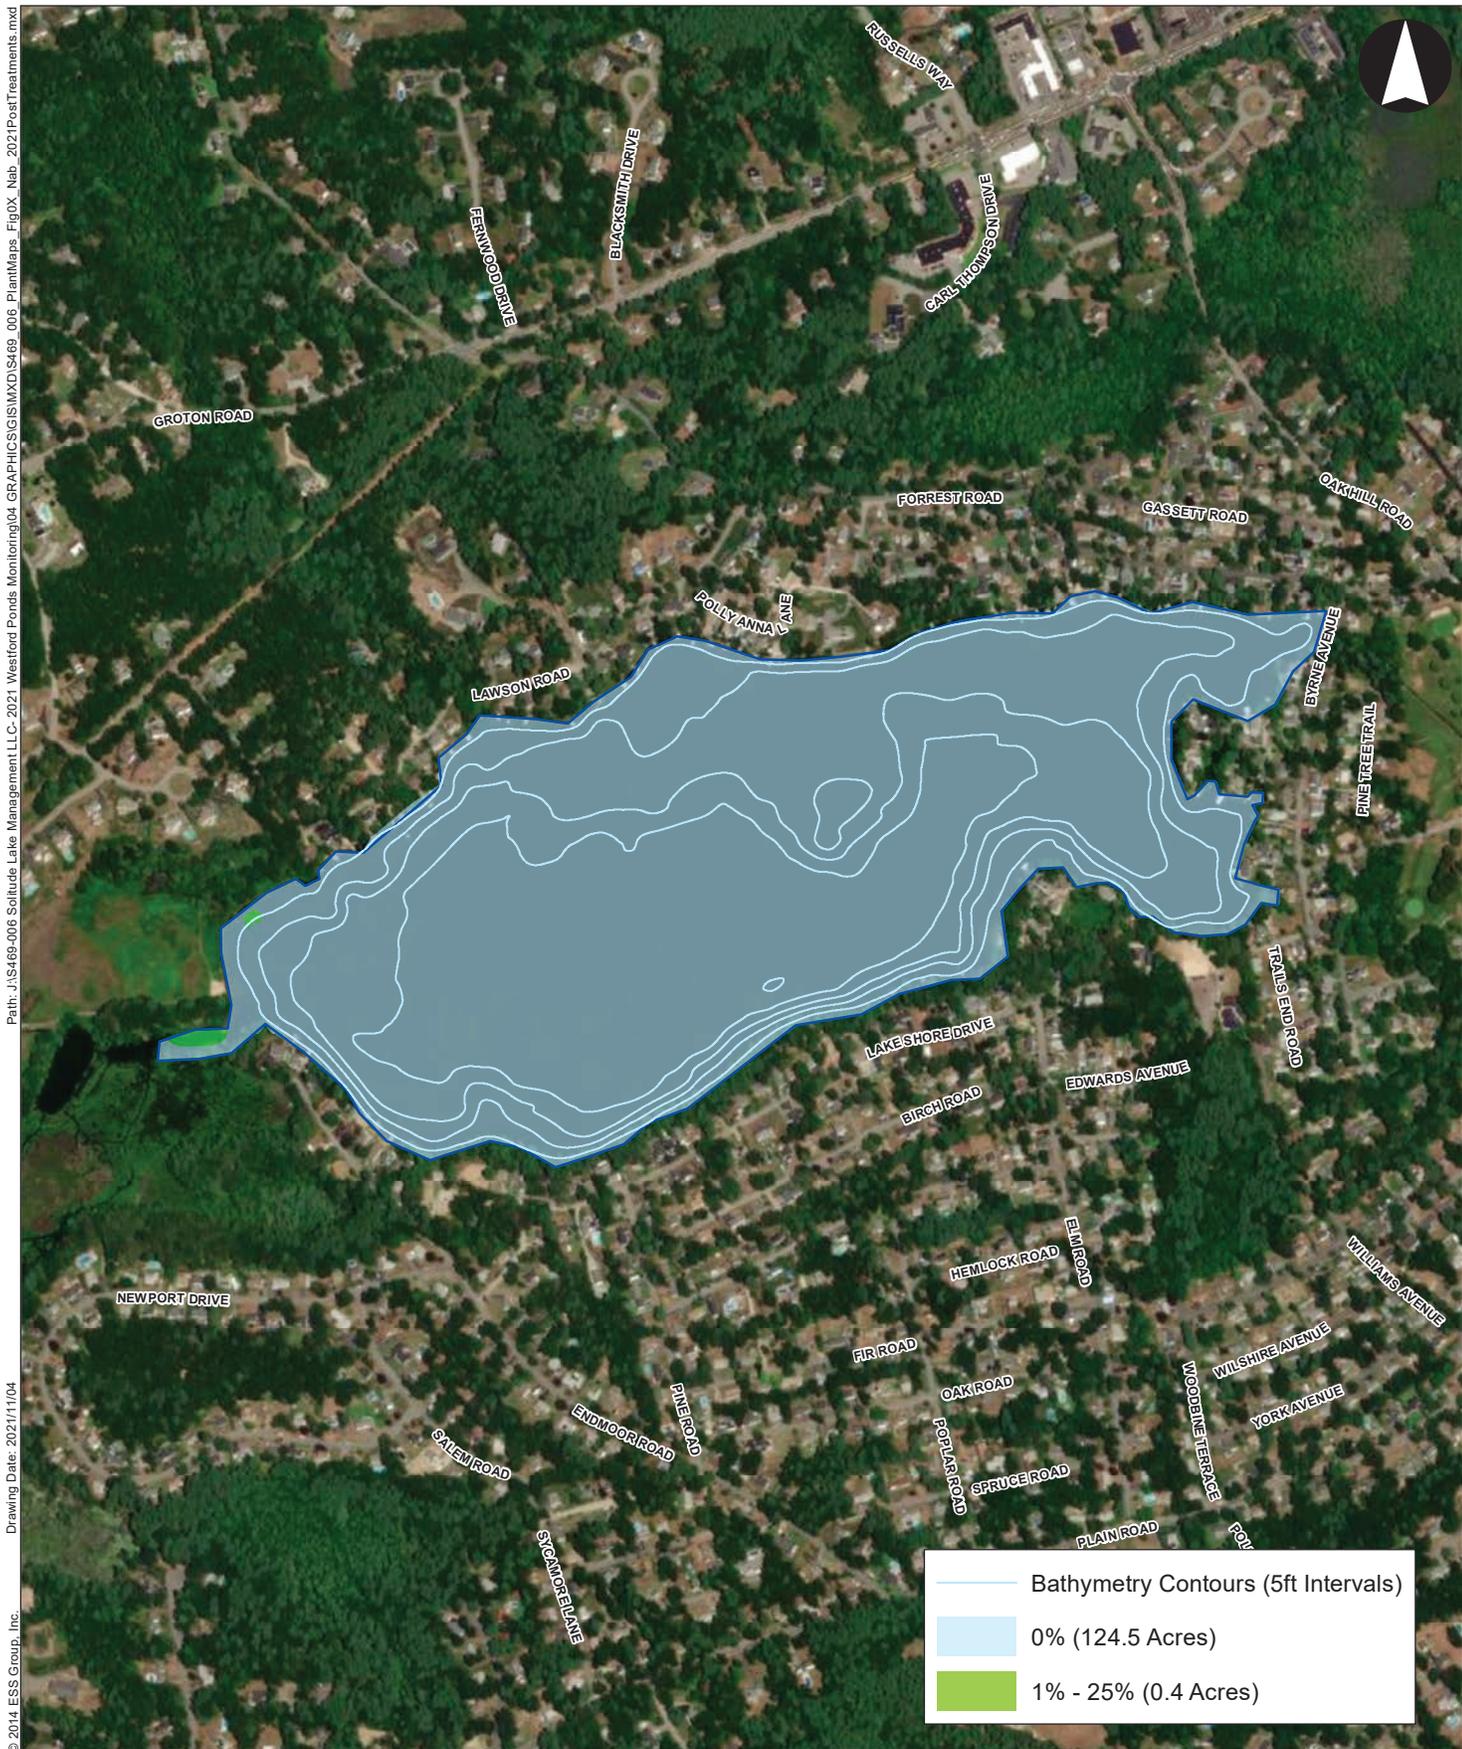
Fifteen species of aquatic plants were observed at Nabnasset Lake during the 2021 post-treatment survey, including one exotic invasive species. Invasive variable-leaf milfoil was confined to sparse beds in Shipley Swamp and in a nearby shoreline location on the northwestern shoreline of Nabnasset Lake (Figure 3). Other aquatic invasive plants observed during the pre-treatment survey, including curly-leaf pondweed (*Potamogeton crispus*) and water chestnut (*Trapa natans*) were not encountered during the post-treatment survey.

**Nabnasset Pond**  
**Variable-Leaf Milfoil Cover**  
**Post-Treatment (September 2021)**

Variable-leaf milfoil made a resurgence at Nabnasset Lake in 2021 but the extent of beds observed there remains low. However, variable-leaf milfoil should be closely monitored for continued regrowth or expansion in Nabnasset Lake and managed as needed to prevent re-establishment of this species.

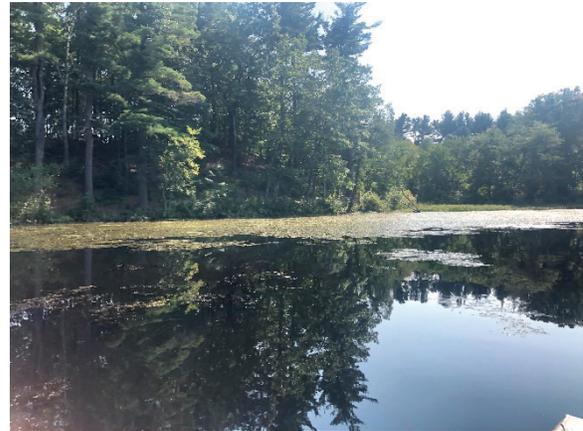
*Very dense bed of fanwort reaching the surface in lower basin of Old Mill/Graniteville Ponds.*

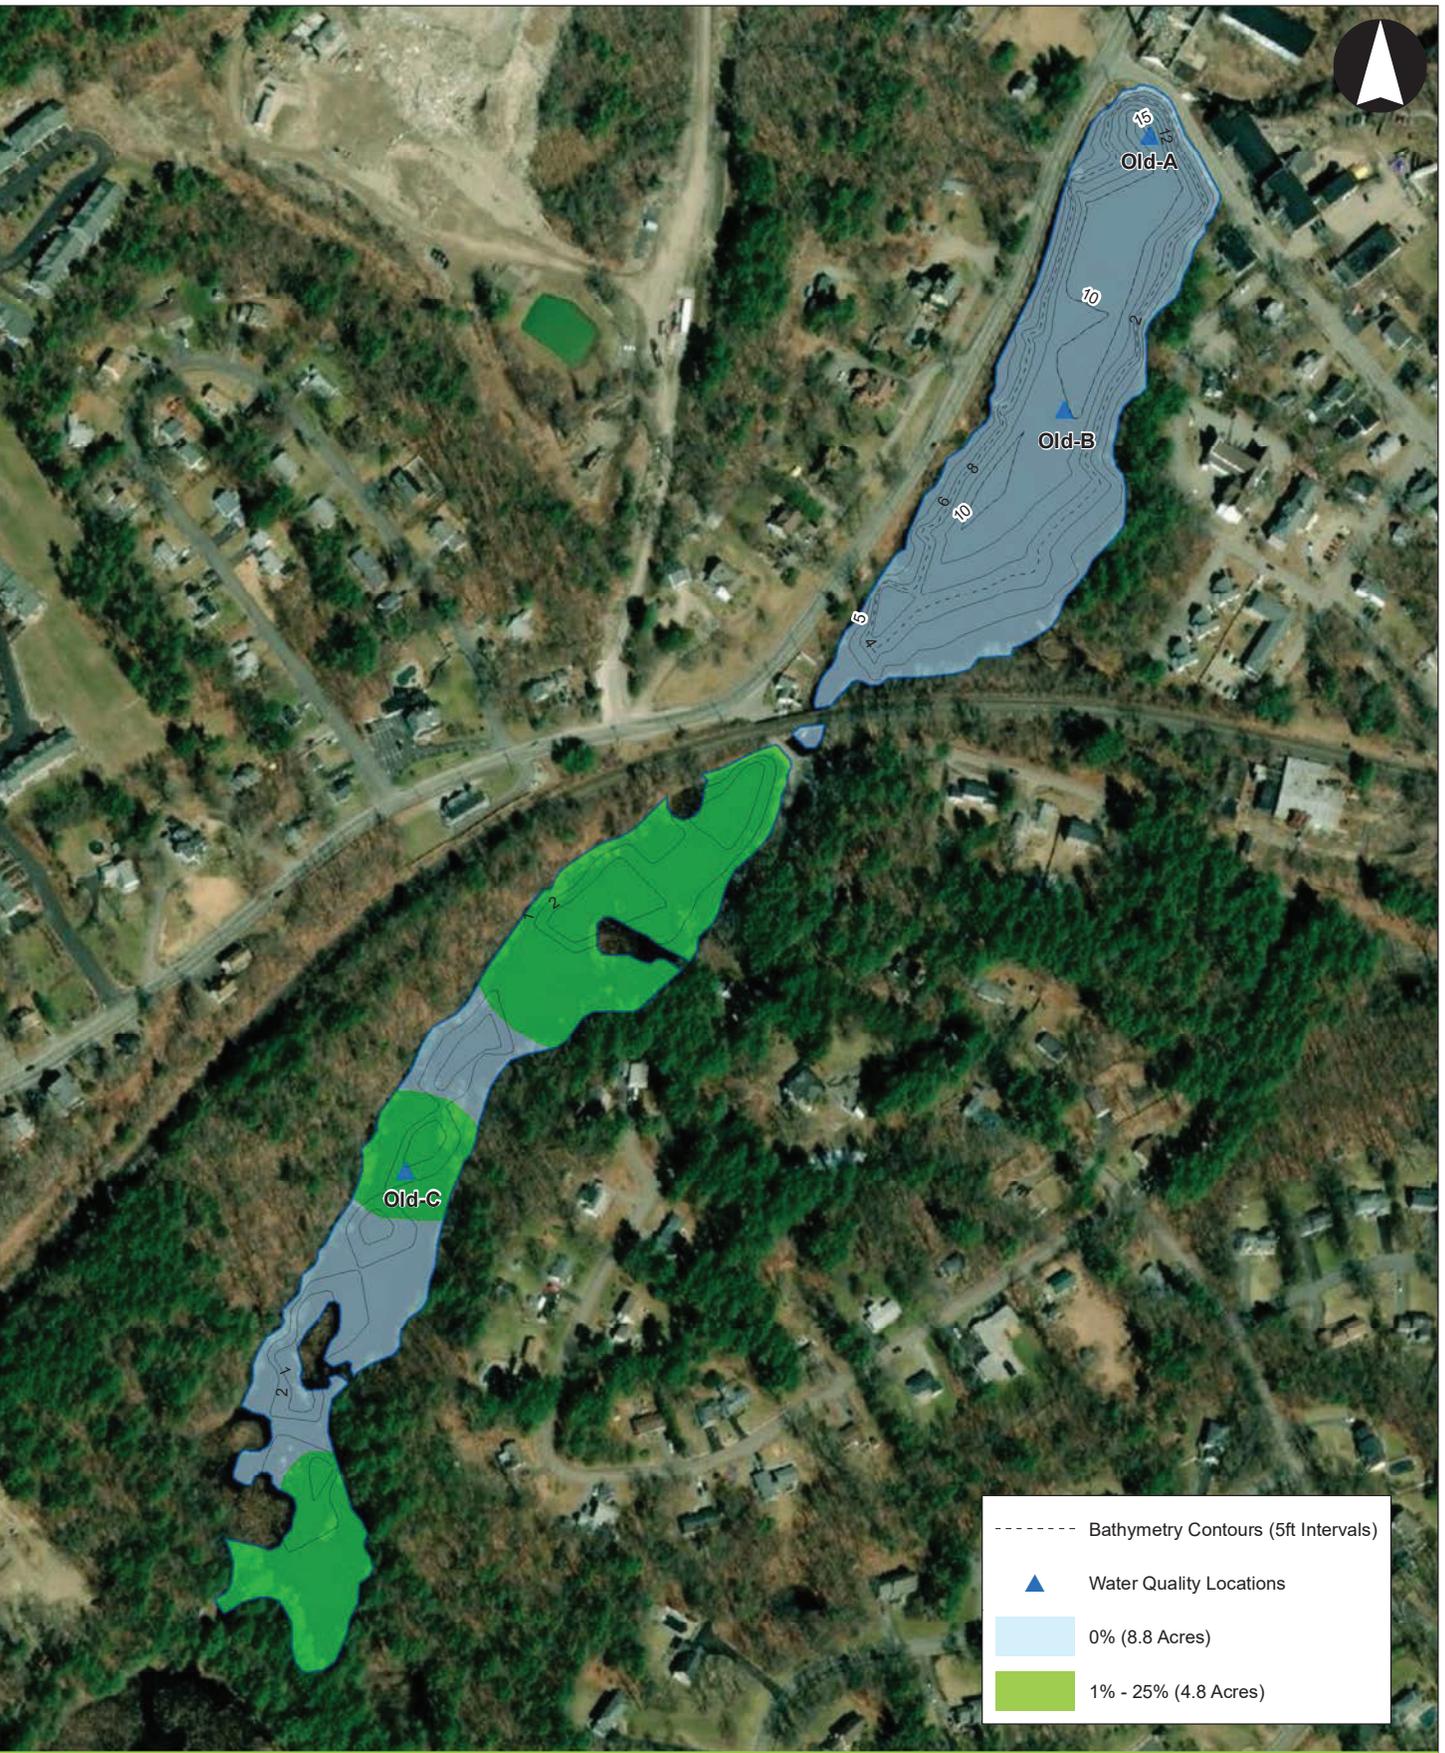
**Figure 5**

Eurasian milfoil was only observed in the upper basin (Figure 5). Although the total area covered was nearly 5 acres, the sparse nature of the beds suggests that the actual area covered by this plant is only a fraction of this.

-----	Bathymetry Contours (5ft Intervals)
▲	Water Quality Locations
Light Blue	0% (8.8 Acres)
Green	1% - 25% (4.8 Acres)

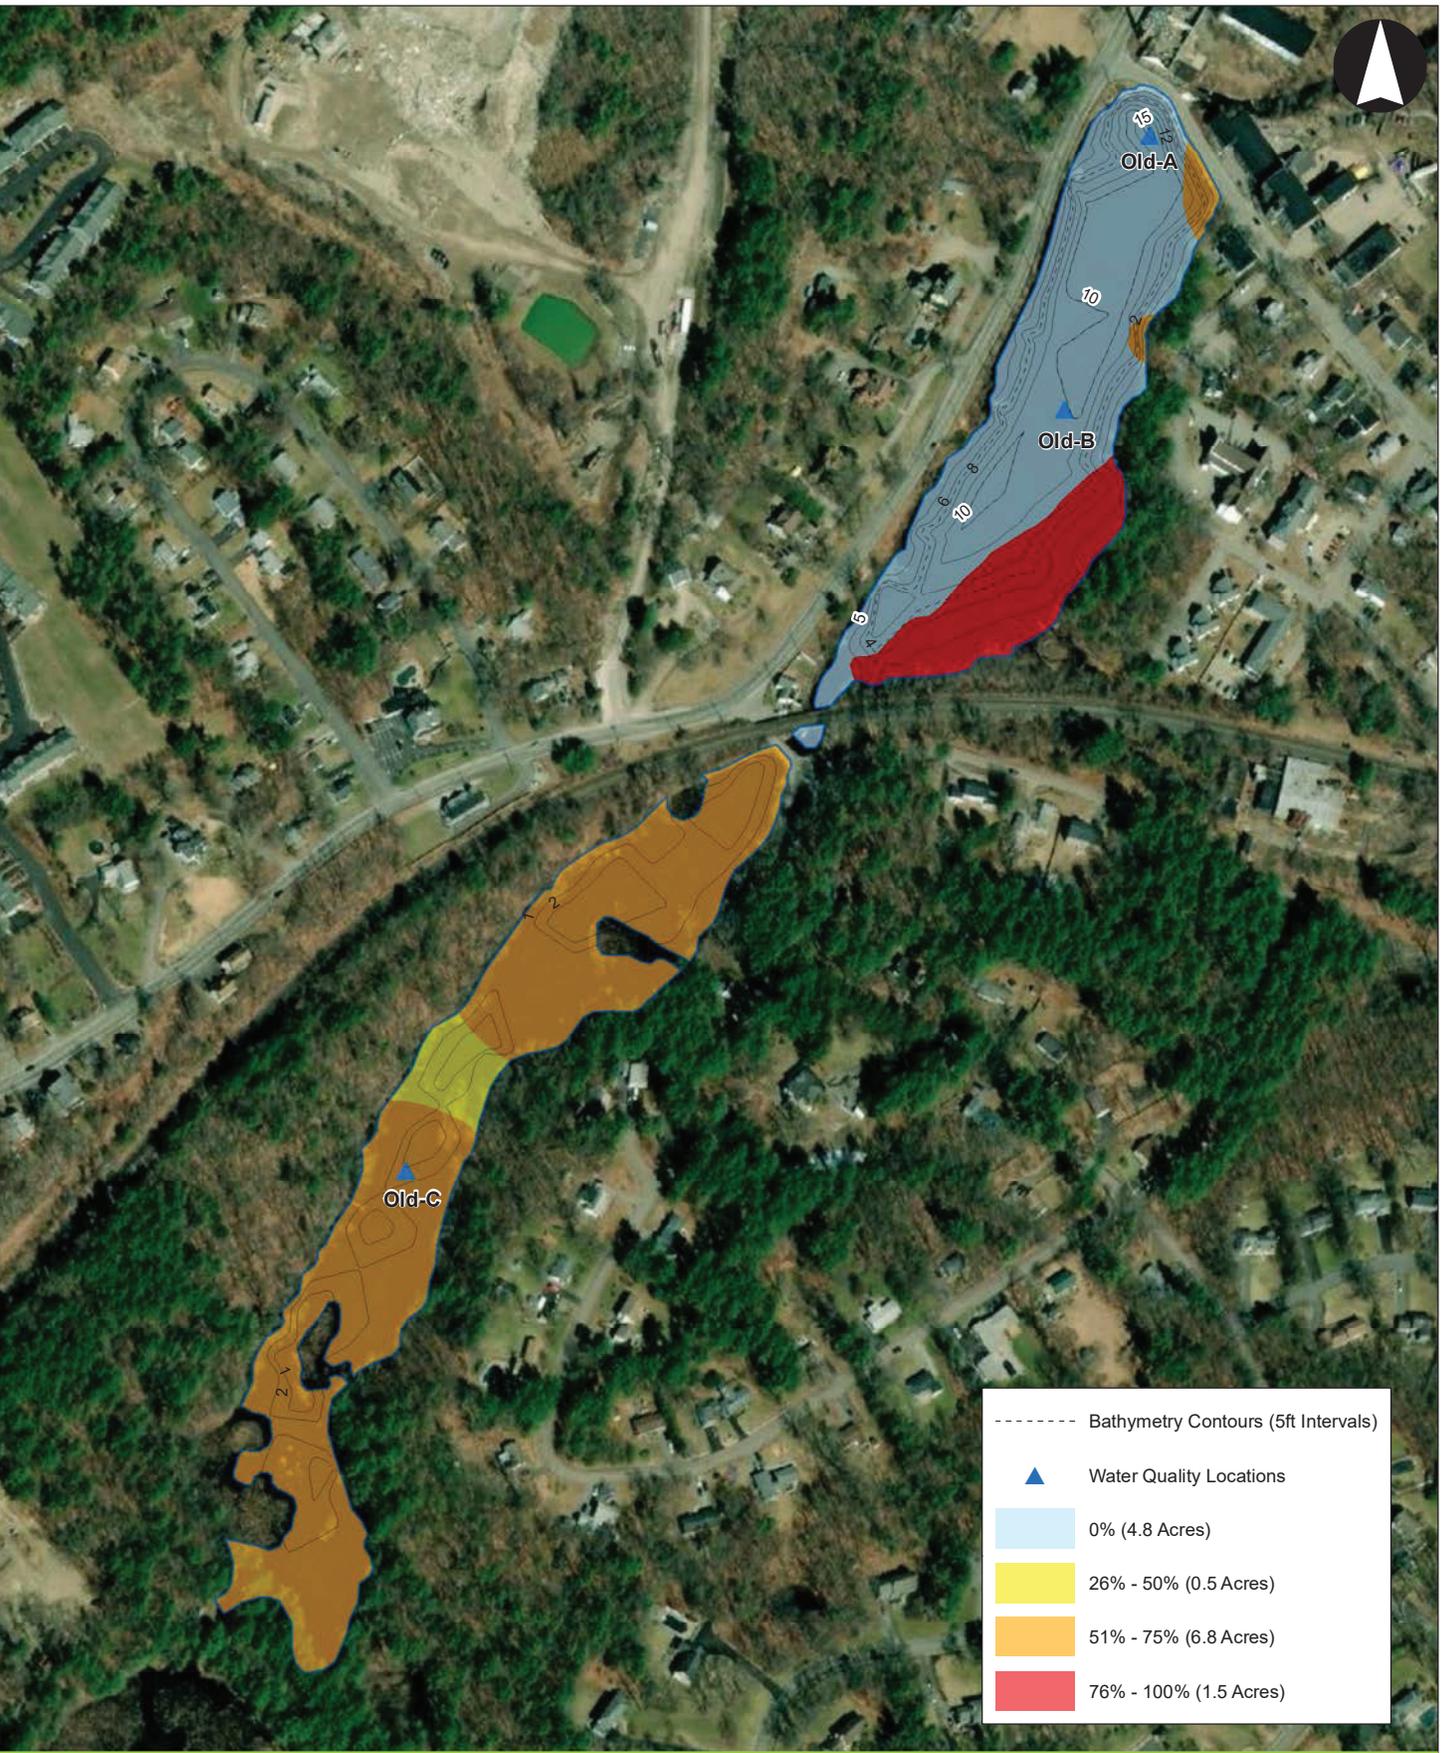
**Figure 6**

Fanwort was found growing in patchy to very dense stands covering 8.8 acres in both basins of the pond during the 2021 late season survey (Figure 6). This represents an increase in overall fanwort extent, compared to the 6.1 acres of growth reported during the 2020 late season survey.

-----	Bathymetry Contours (5ft Intervals)
▲	Water Quality Locations
Light Blue	0% (4.8 Acres)
Yellow	26% - 50% (0.5 Acres)
Orange	51% - 75% (6.8 Acres)
Red	76% - 100% (1.5 Acres)
