**Annual Report**  
2021 Management Program  
Westford Ponds  
Westford, MA

Prepared by: SÖLitude Lake Management  
590 Lake Street  
Shrewsbury, MA 01545

Prepared for: Town of Westford  
c/o Rae Dick & Matthew Salem  
55 Main Street  
Westford, MA 01886

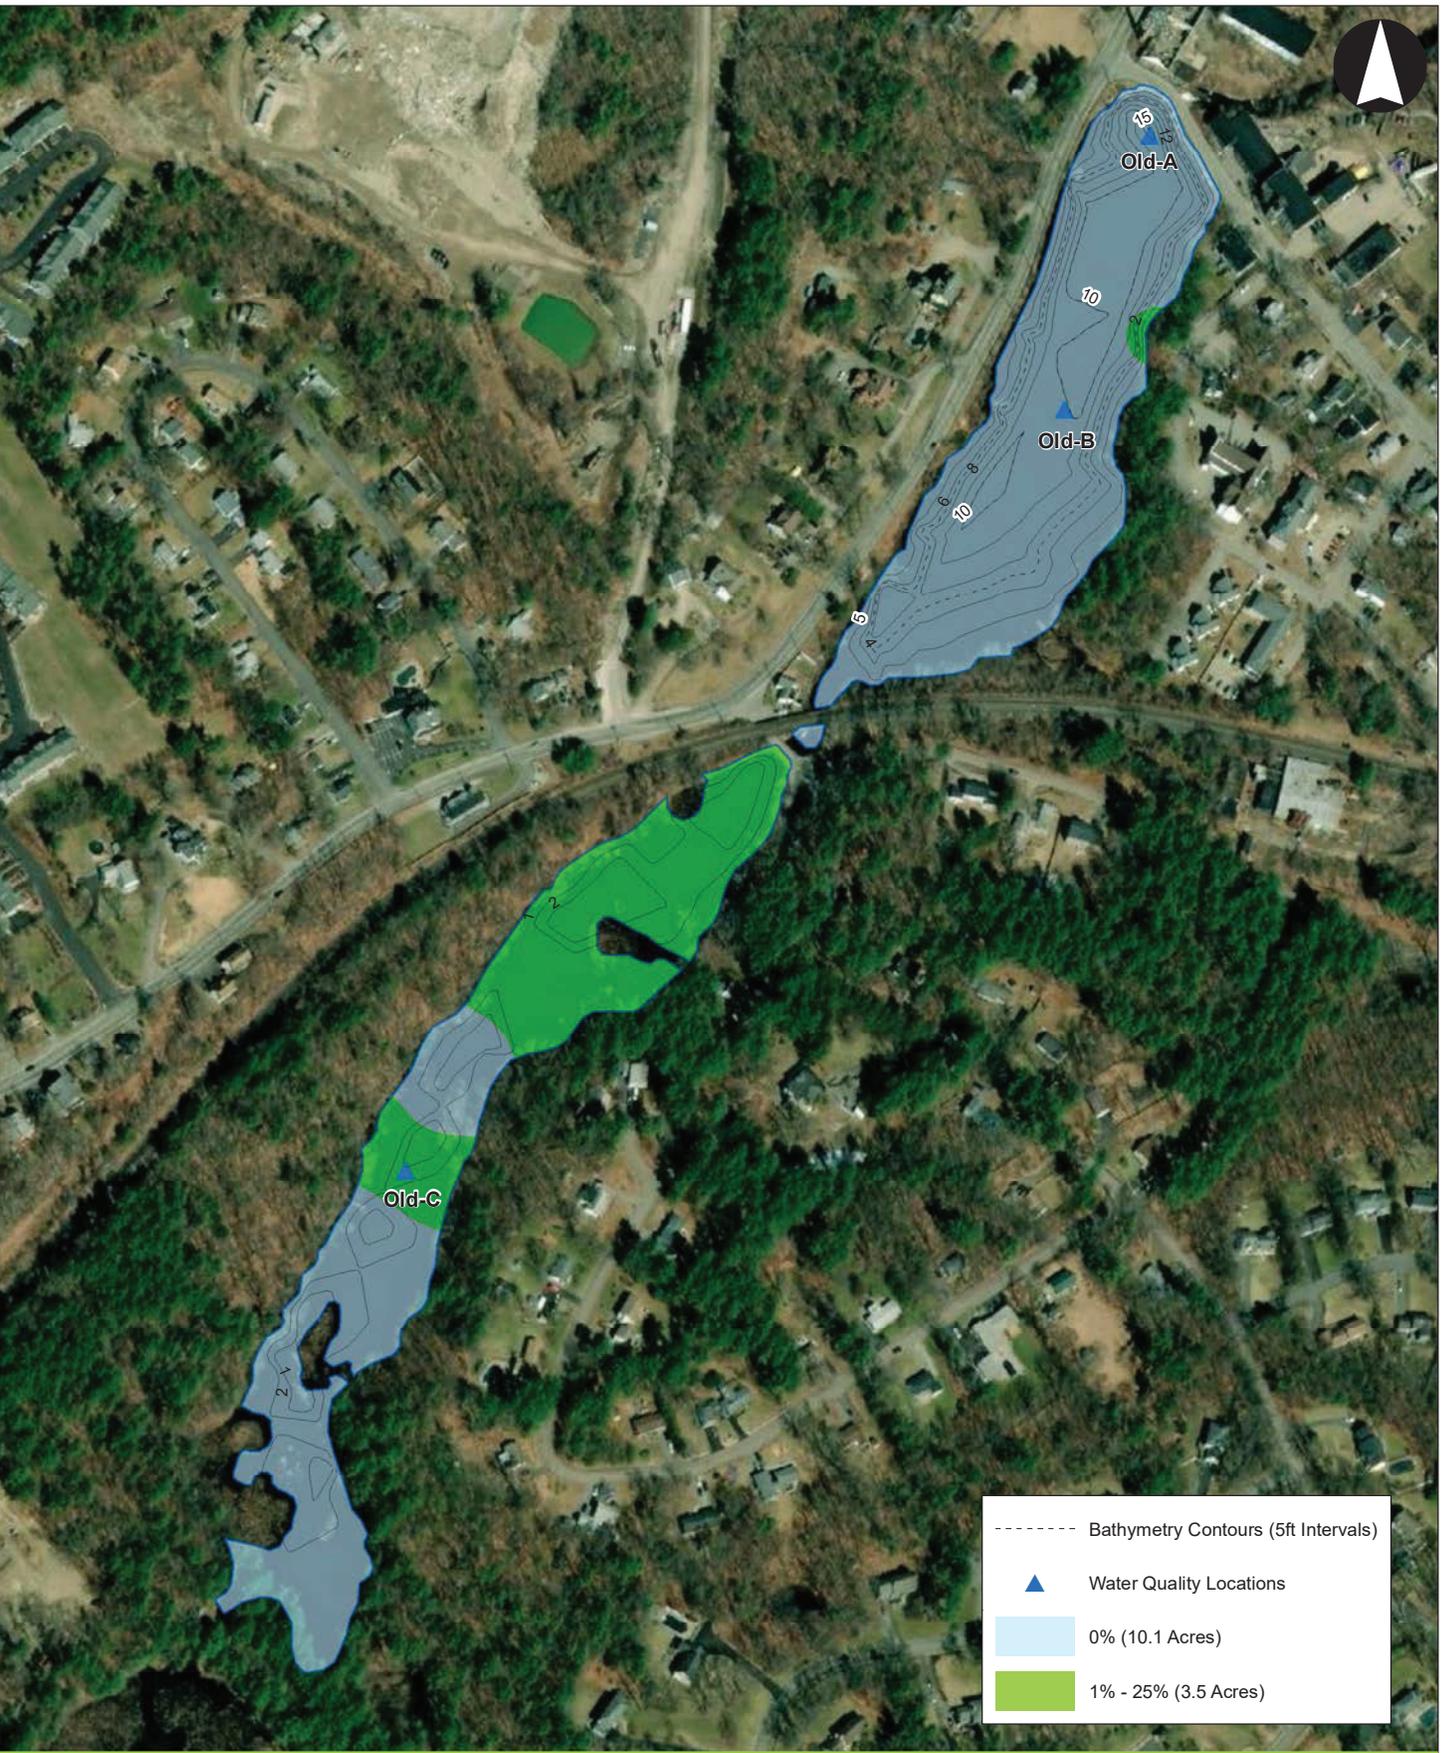
**Figure 7**

Variable-leaf milfoil was observed growing in sparse beds in both basins of the Old Mill/ Graniteville Ponds during the 2021 late season survey (Figure 7). Cover of this species was approximately 3.5 acres, which is higher than observed during the 2021 late season survey.

-----	Bathymetry Contours (5ft Intervals)
▲	Water Quality Locations
Light Blue	0% (10.1 Acres)
Green	1% - 25% (3.5 Acres)

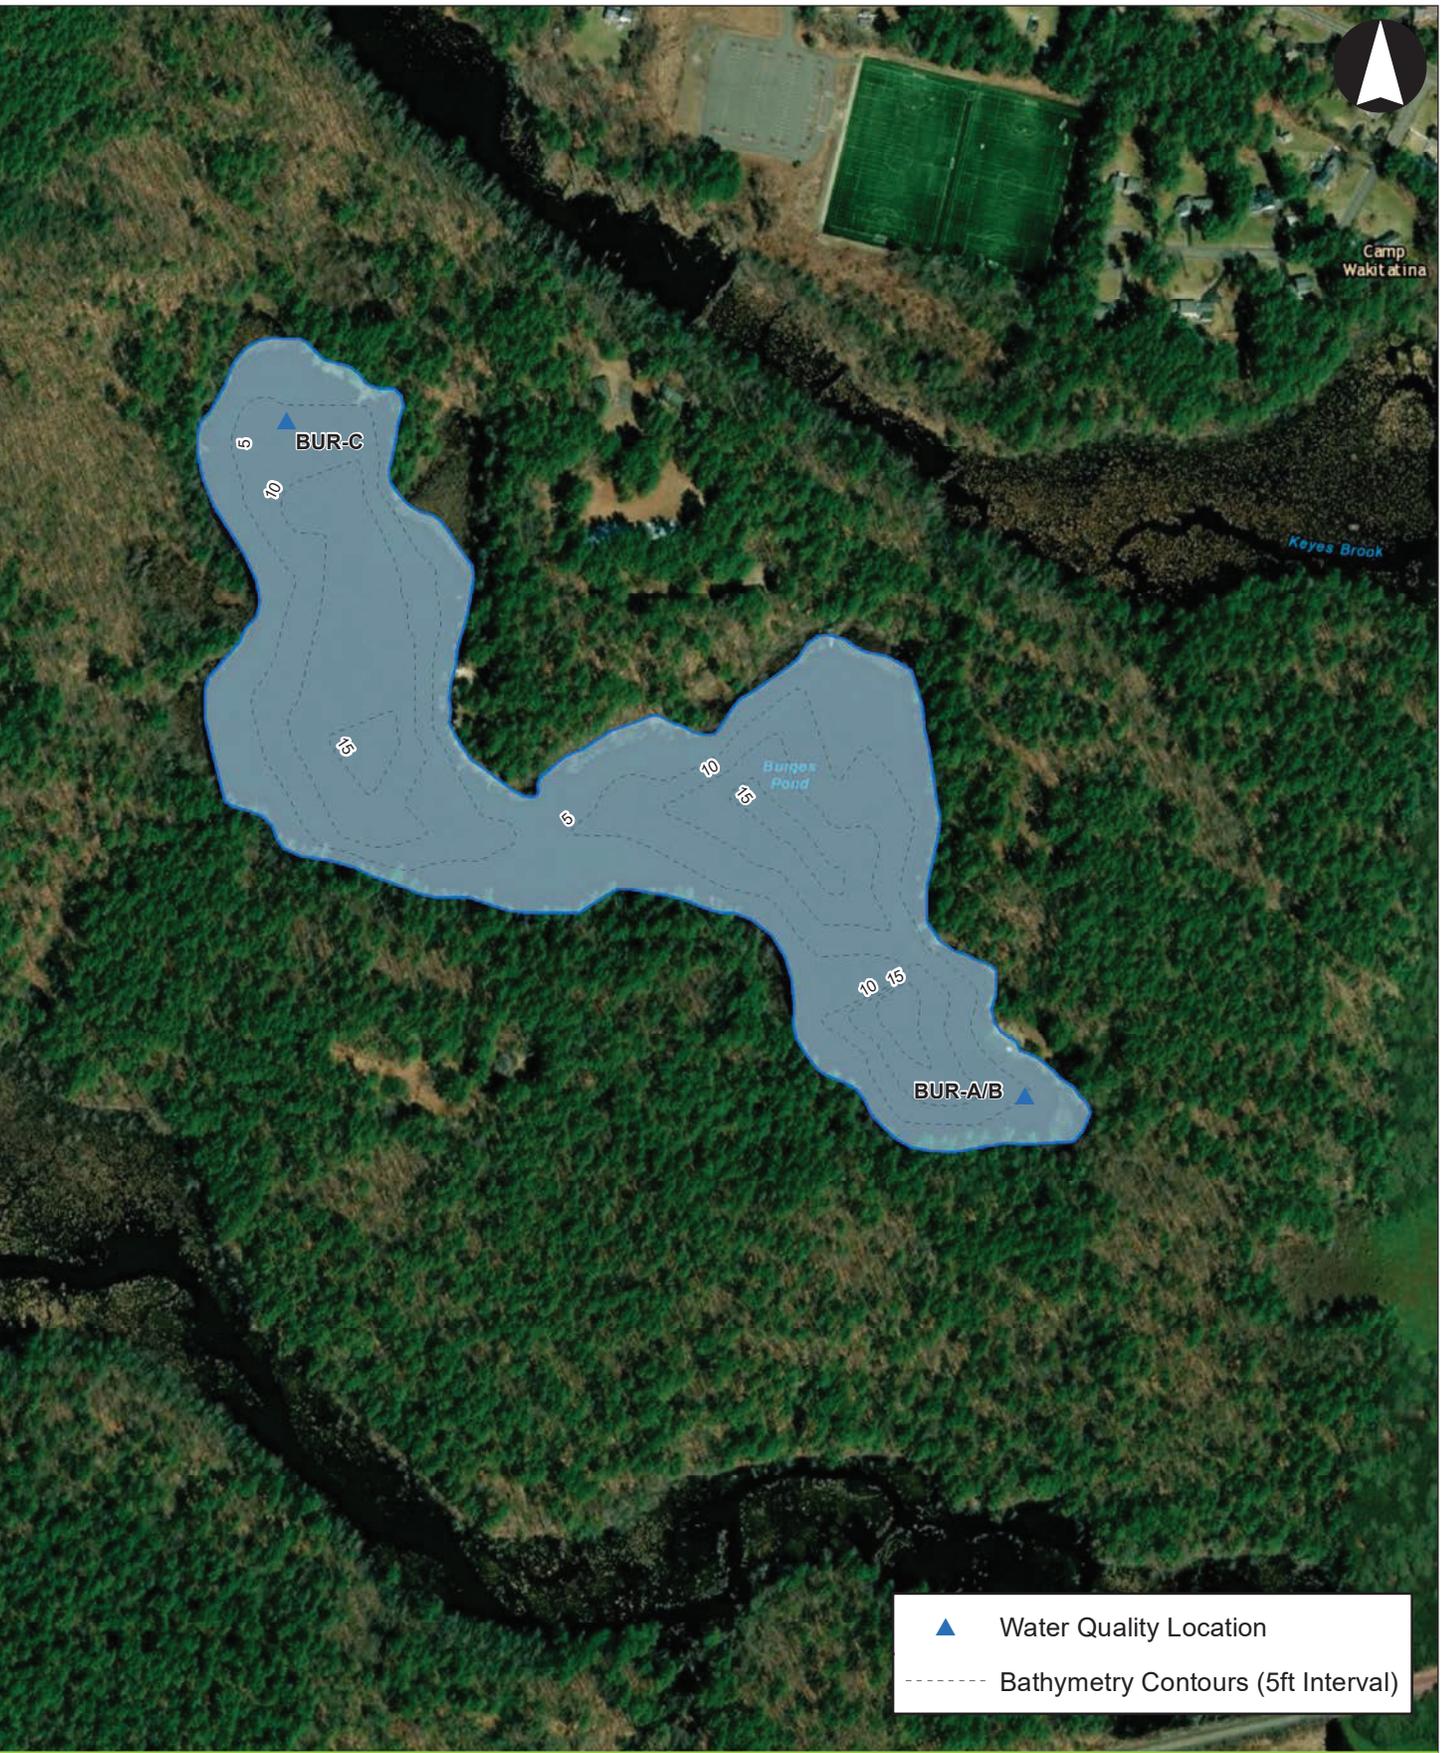
**Figure 8**

Eight species of aquatic plants were found in Burge's Pond during the 2021 late season survey. No aquatic invasive plant species were observed in 2021 (Figure 8), which is consistent with prior mapping of Burge's Pond dating back to post-treatment mapping completed in 2016. Based on these survey results, the control of variable-leaf milfoil previously achieved appears to persist.

**Burge's Pond**  
**Water Quality Sampling Locations**  
**Post-Treatment (September 2021)**

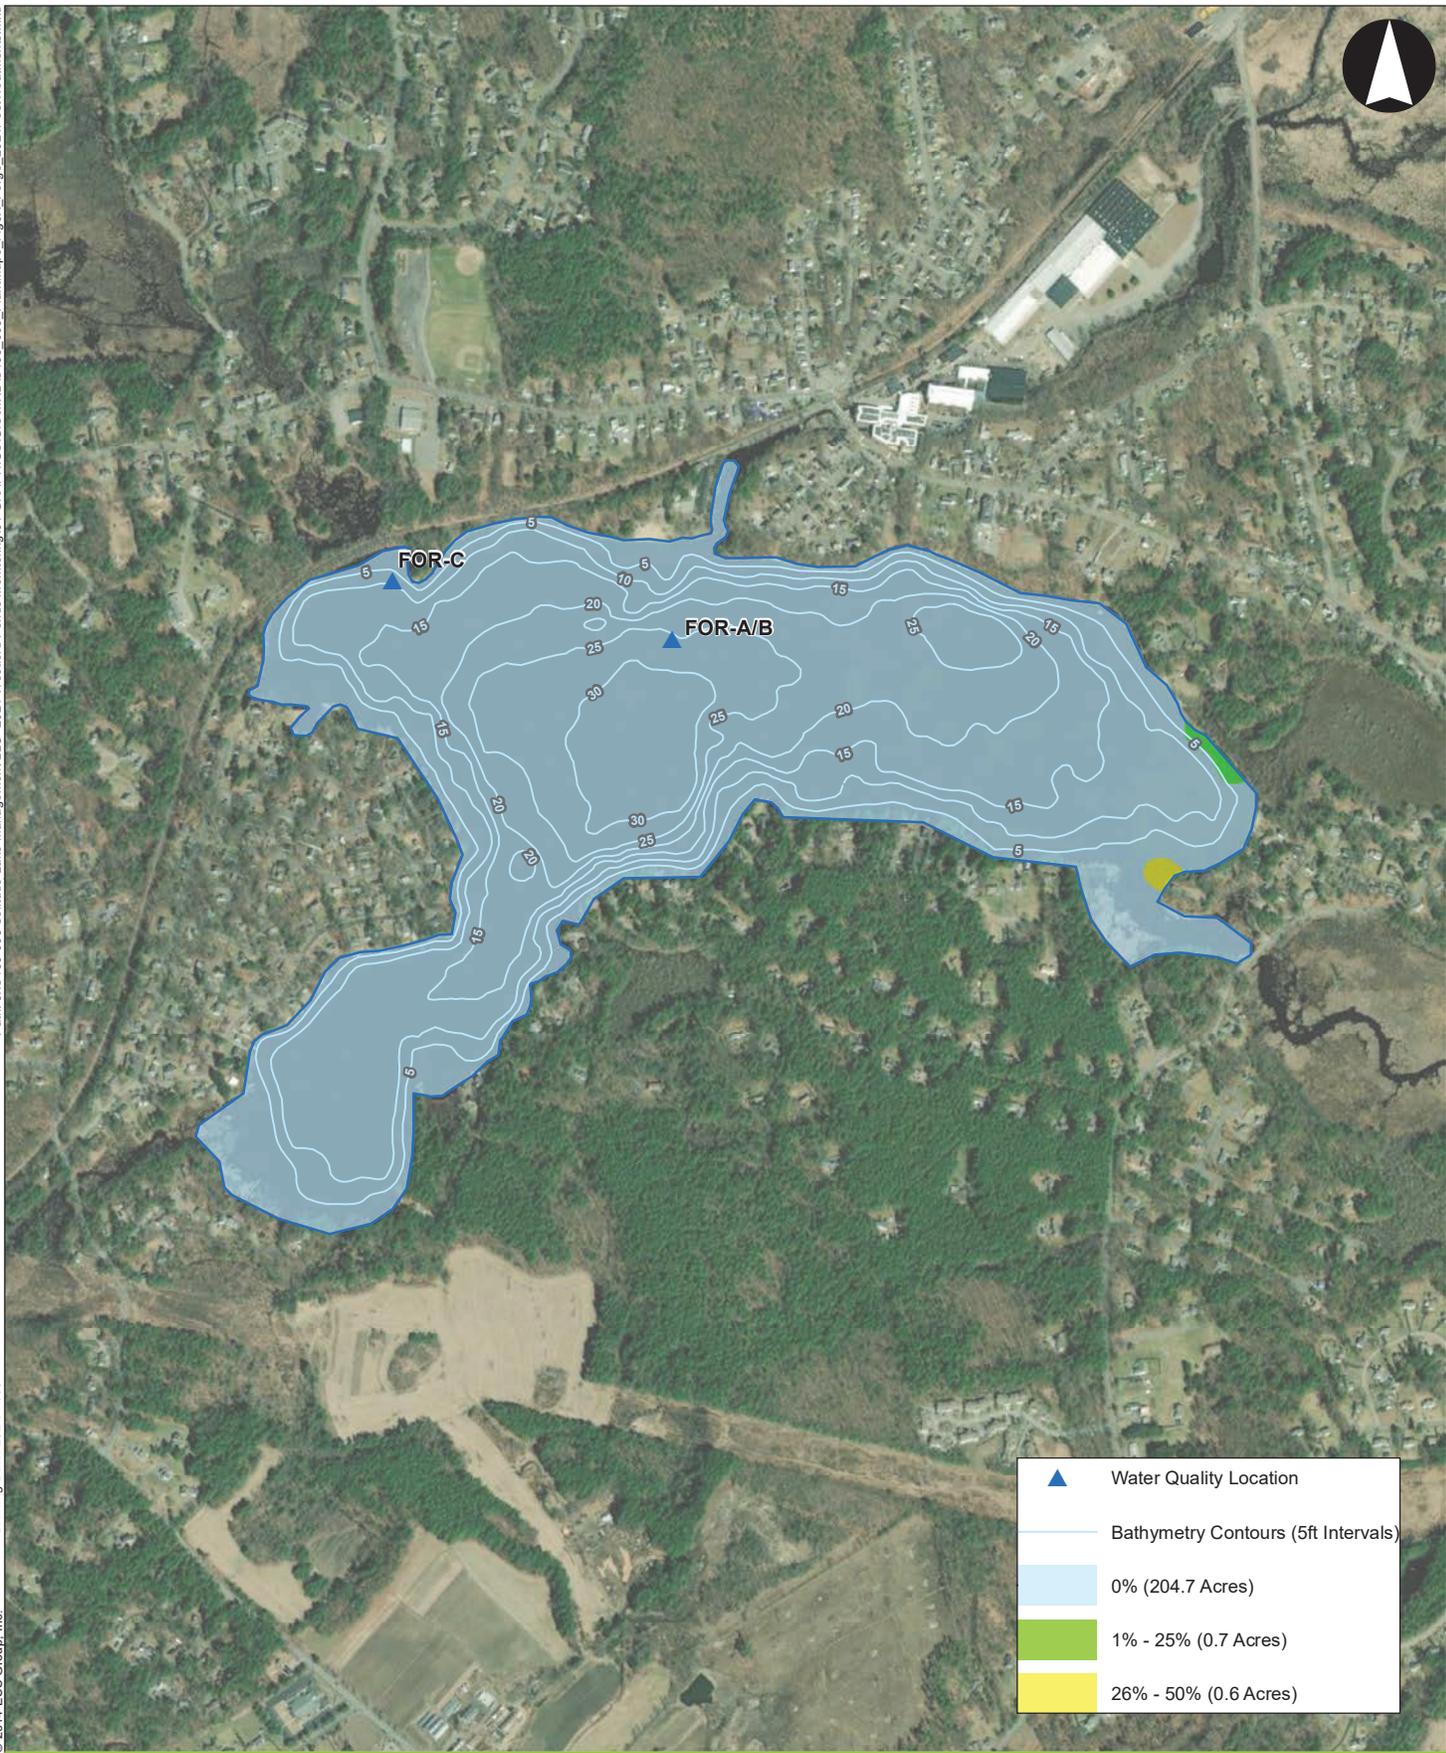
**Figure 10**

Brittle naiad cover in Forge Pond was observed to be just over an acre in extent, occurring primarily as sparse to patchy growth (Figure 10). Growth was confined to shoreline areas on the eastern side of the pond inside the Westford town line.

Water Quality Location
	Bathymetry Contours (5ft Intervals)
	0% (204.7 Acres)
	1% - 25% (0.7 Acres)
	26% - 50% (0.6 Acres)

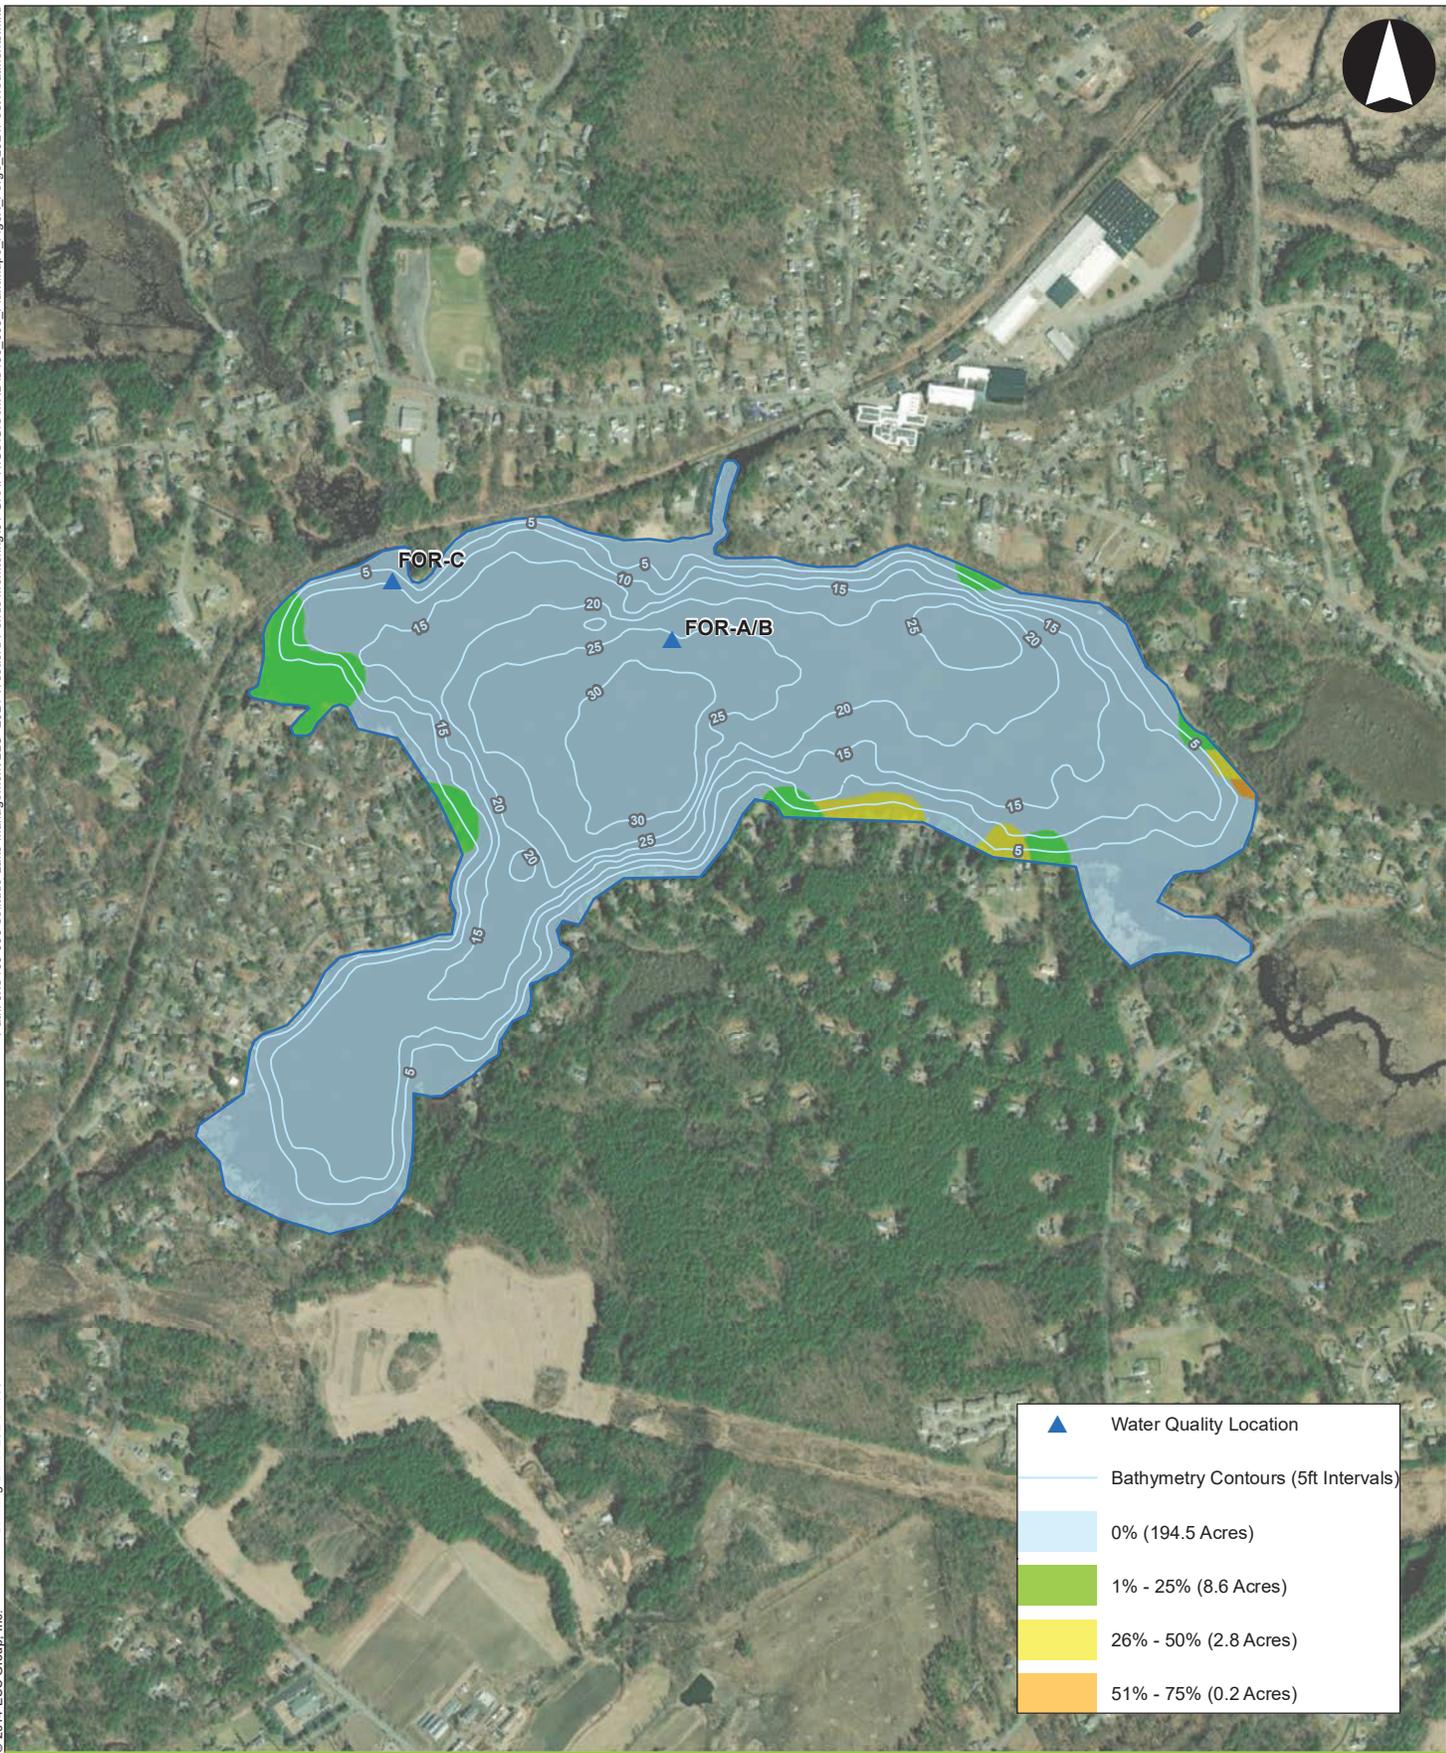
**Figure 11**

Eurasian milfoil was observed in mostly sparse to patchy beds covering approximately 12 acres of Forge Pond during the 2021 late season survey (Figure 11). This includes some beds on the Littleton side of the pond that would not have been mapped in prior years.

Water Quality Location
	Bathymetry Contours (5ft Intervals)
	0% (194.5 Acres)
	1% - 25% (8.6 Acres)
	26% - 50% (2.8 Acres)
	51% - 75% (0.2 Acres)

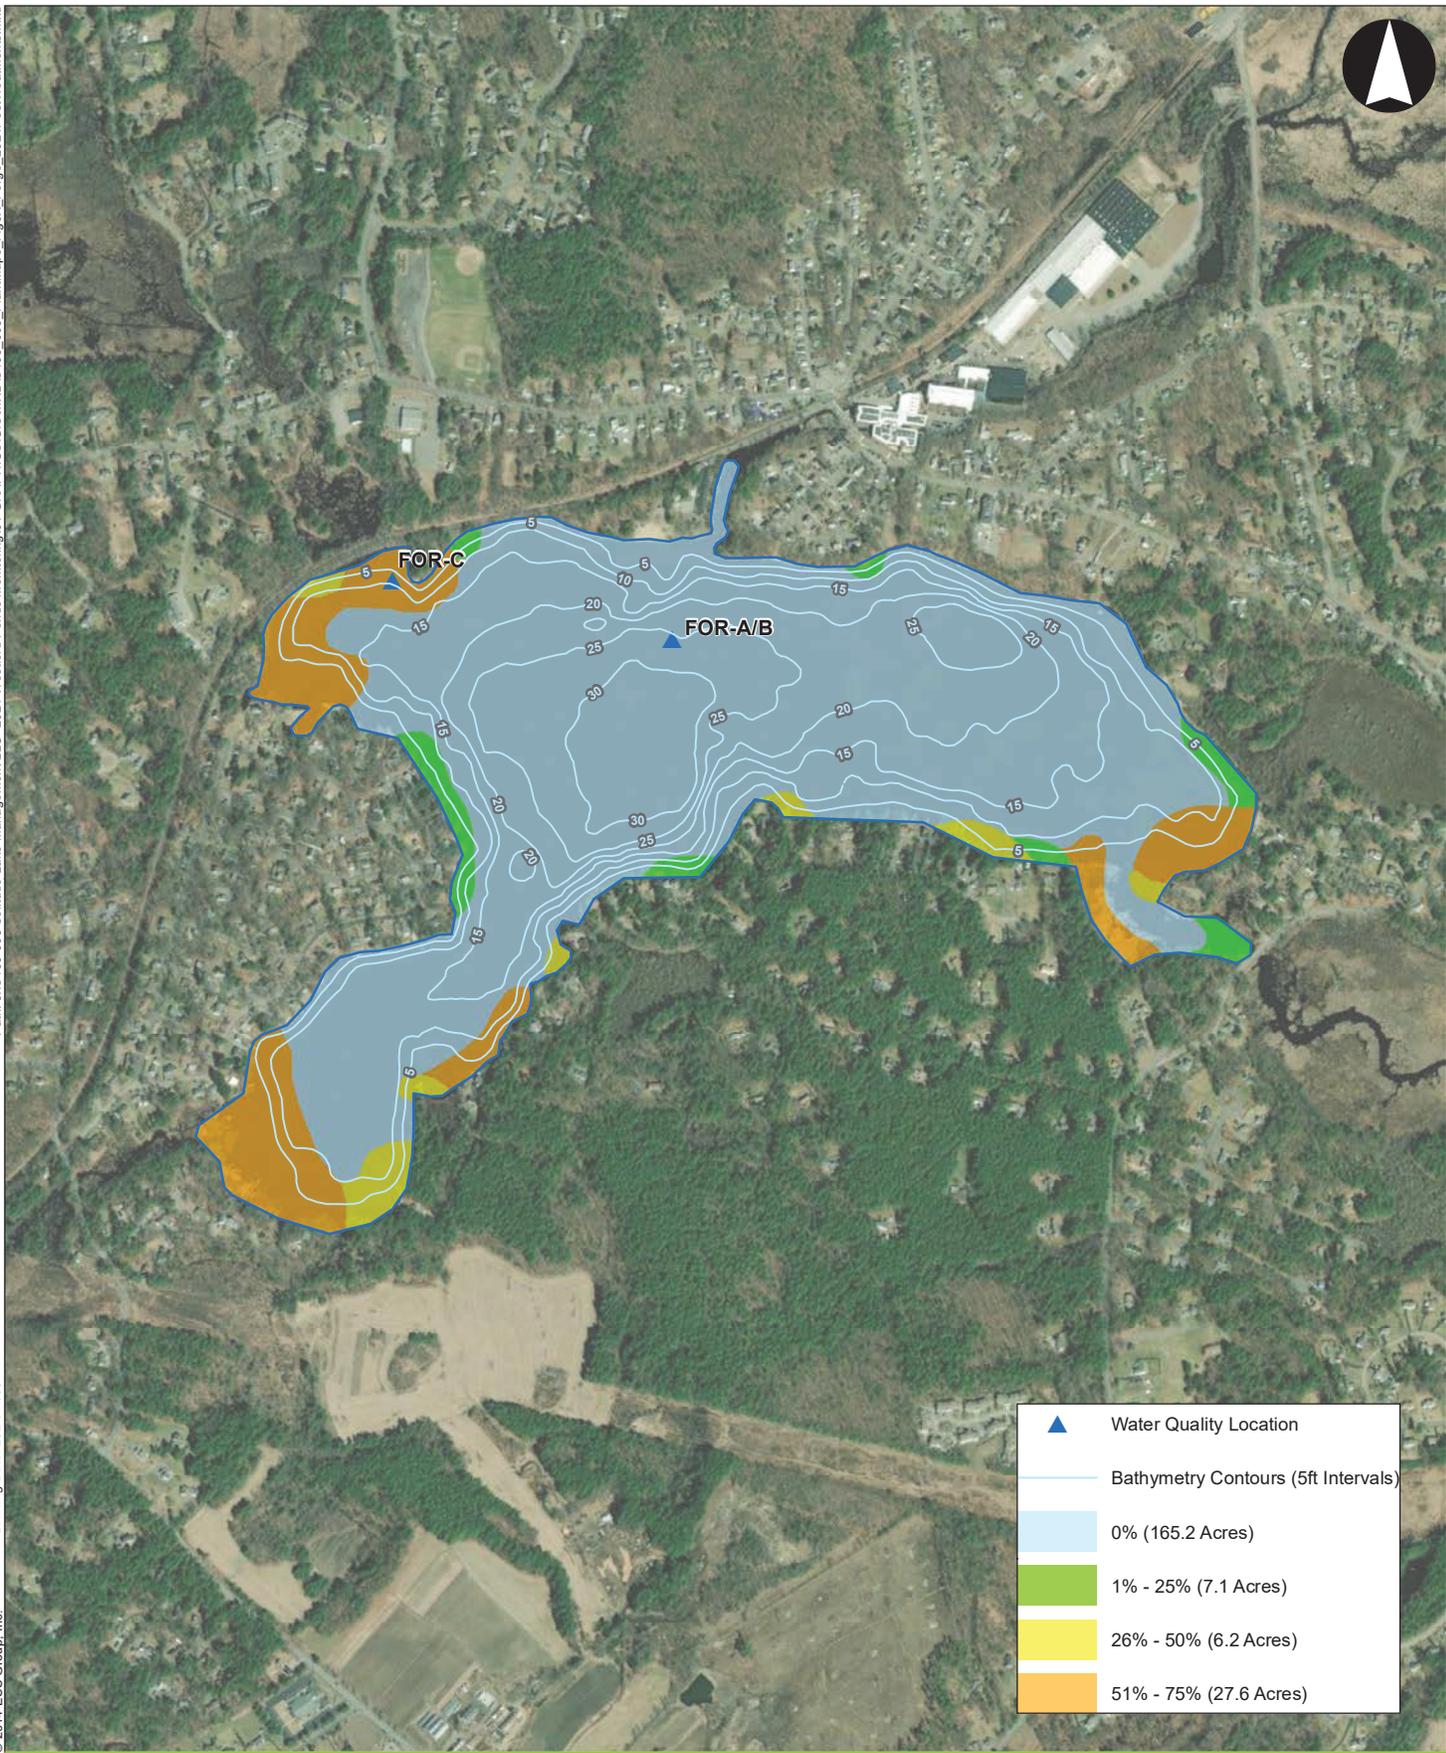
**Figure 12**

Fanwort was observed in extensive beds covering approximately 41 acres (Figure 12). Most beds were dense, with a few areas of sparse to patchy growth. Fanwort was the dominant aquatic plant species on the Littleton side of the pond.

Water Quality Location
	Bathymetry Contours (5ft Intervals)
	0% (165.2 Acres)
	1% - 25% (7.1 Acres)
	26% - 50% (6.2 Acres)
	51% - 75% (27.6 Acres)
