# Accessibility Audit

Prepared by Direct Access Consultancy LLC

June 2024

Westford Town Buildings  
Westford, MA 01886

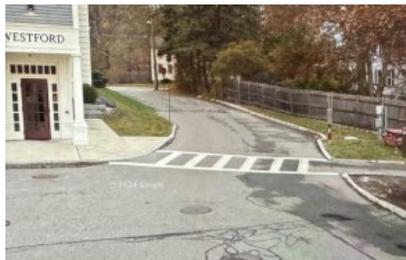
Recommendation:  
Install detectible warning surface on curb ramp

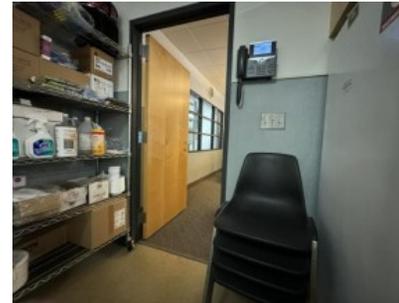
**Finding: 15**

**Internal: Accessible Route**

**Recommendation:**

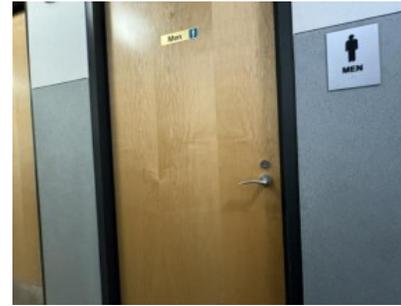
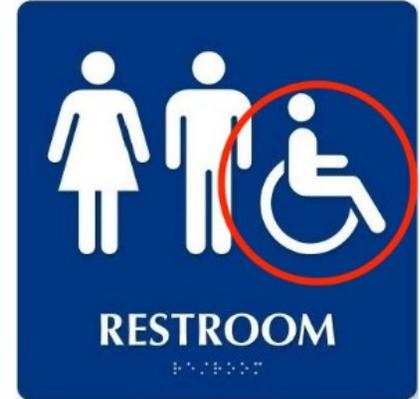
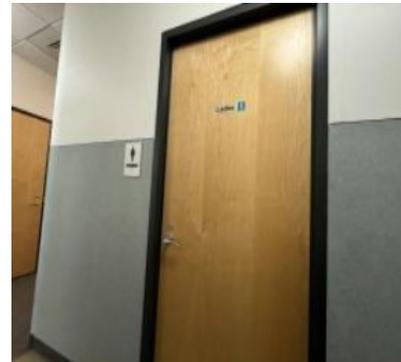
**Finding: 18**

**Internal: Accessible Restroom**

**Recommendation:**

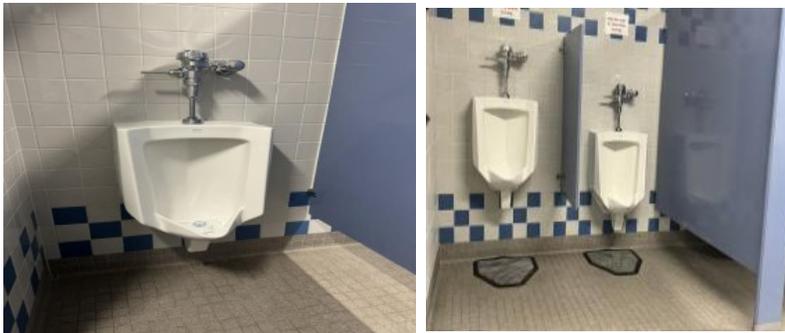
Finding: 10

Internal: Bathroom

Recommendation:

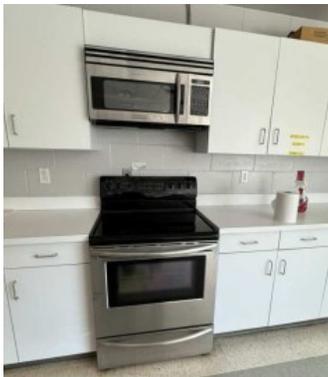
Finding: 17

Internal: Lunchroom

Recommendation:  
Countertop is at 36" high and should be 34" maximum above the finished floor.

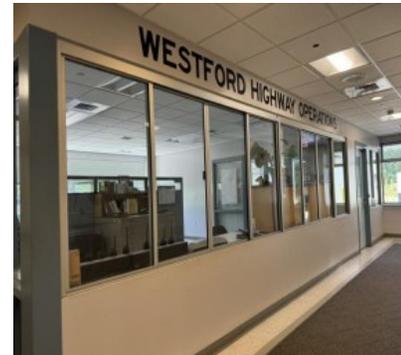
**Finding: 24**

**Internal: Door to Elevator**

Compliant room identification signs are missing.

**Recommendation:**

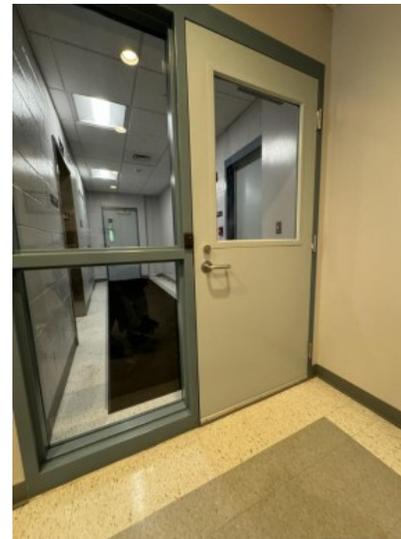
**Finding: 25**

**Internal: Foot Operated Mechanism**

**Recommendation:**

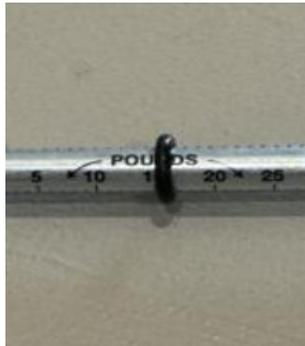
Finding: 9

Internal: Exit Doors

The required exit sign with the ISA is missing above the door.

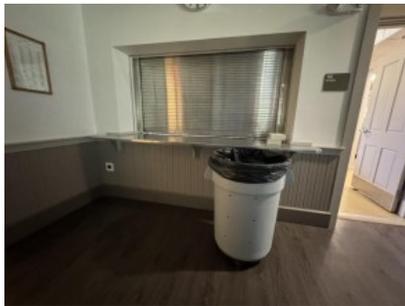
Finding: 11

Internal: Areas of Refuge

Compliant room identification signs are missing.

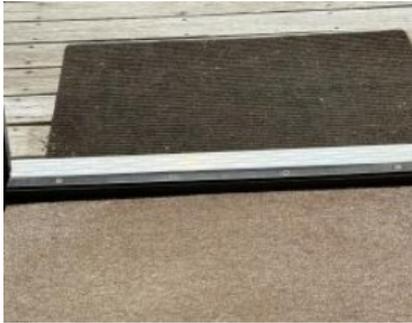
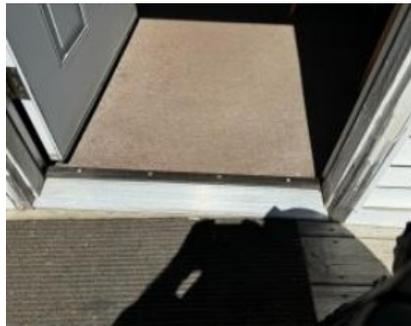
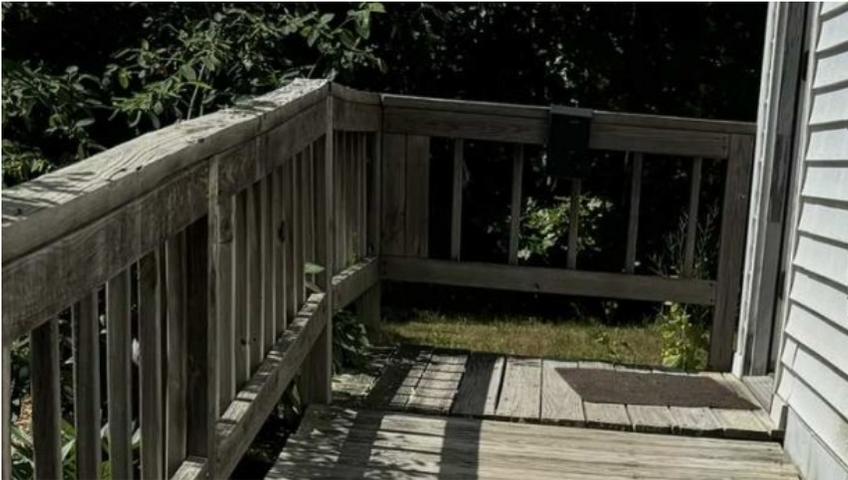
**Finding: 5**

**External: Ramp**

Elevation difference of 3/4" between landing area, office entrance and ramp run which causes a potential tripping hazard.

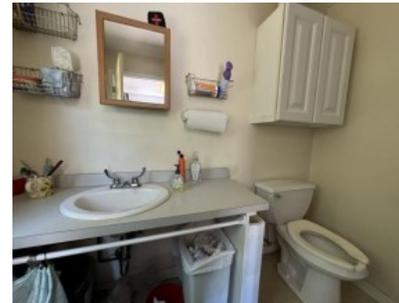
Finding: 14

Internal: Restroom

Recommendation: Lower the mirror and bins so they are no more than 40" above the finished floor.

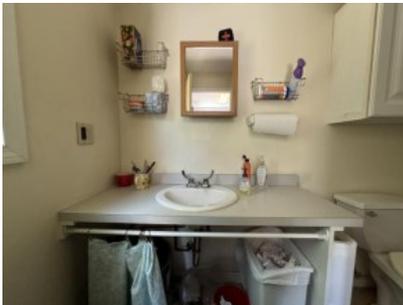
Finding: 15

Internal: Restroom

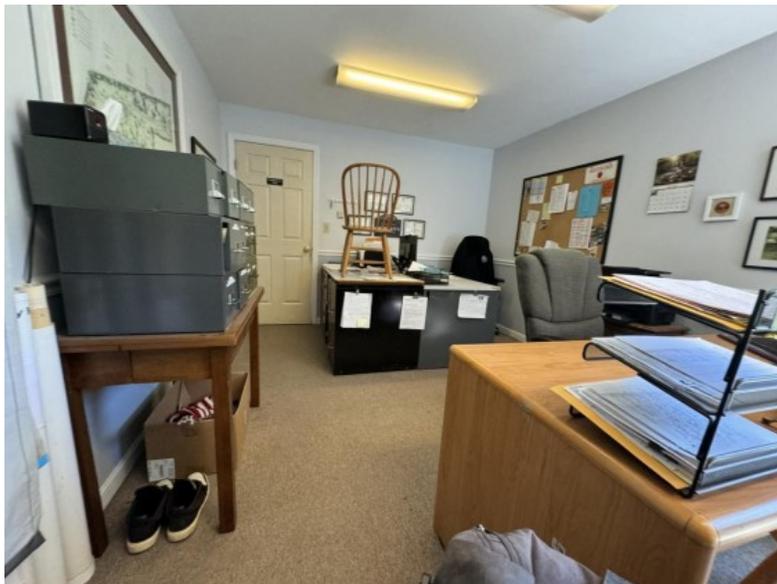
Finding: 16 (Continued)

Internal: Exit Door

Recommendation:
