# Accessibility Audit

Prepared by Direct Access Consultancy LLC

September 2024

Westford Schools, Children's Centers & Museum

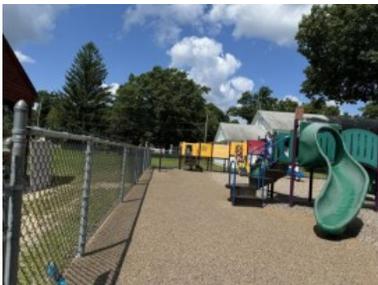
**Finding: 7**

Landscape mats that sit over Engineered Wood Fiber (EWF) have ties that are broken and need replacing.

Replace all broken ties with stronger ties. Investigate ties at least every month given use during the school year. Ties and mats deteriorate quickly from exposure to ultraviolet rays.

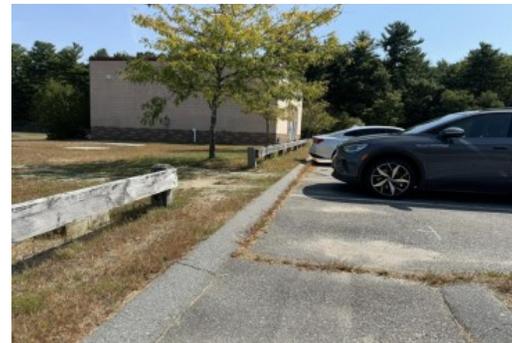
Finding: 9

External: Accessible Route

The accessible route contains loose gravel and/or surface materials that do not provide for a stable, firm slip resistant surface.

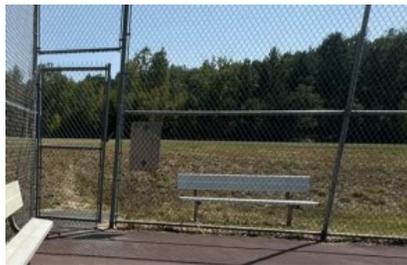
Finding: 13

External: Tennis Courts

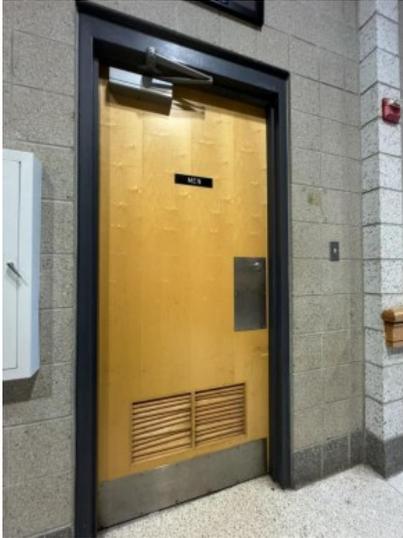
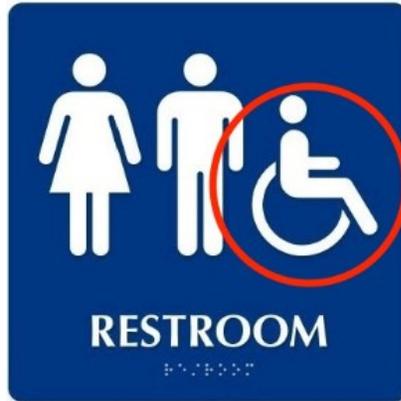
Finding: 3 (Continued)

The restroom is missing the International Symbol of Accessibility (ISA).

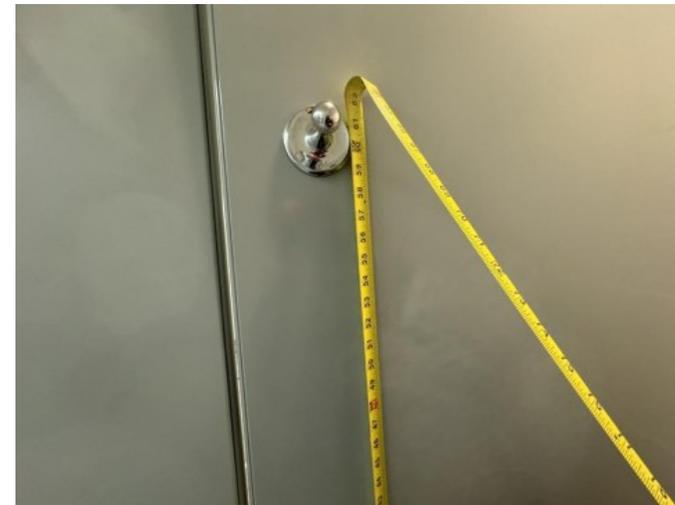
Finding: 4

Internal : Restroom

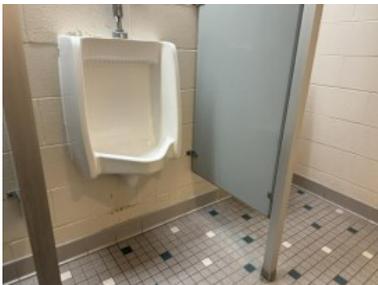
Finding: 6

Internal : Restroom

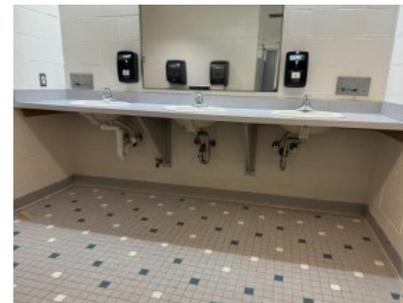
Finding: 7

Internal : Restroom

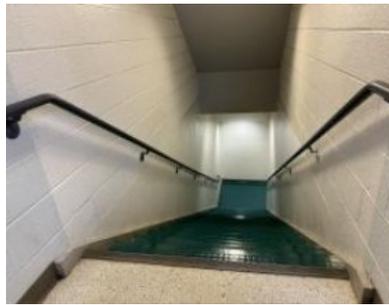
**Finding: 8**

**Internal : Stairways**

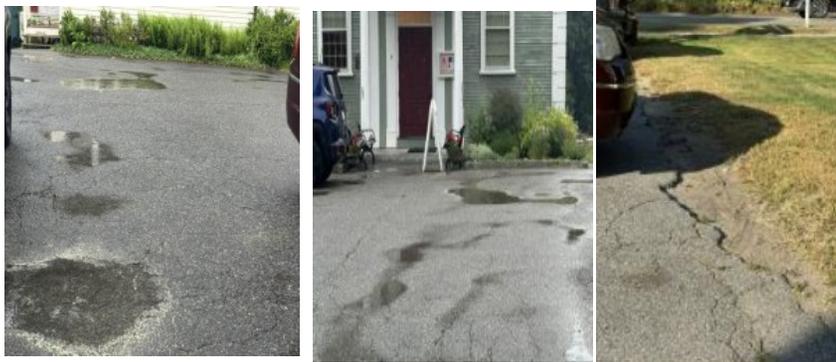
**External: Parking Lot**

**Recommendation:**  
Repave and repair entire parking lot where cars park in non-defined parking areas.

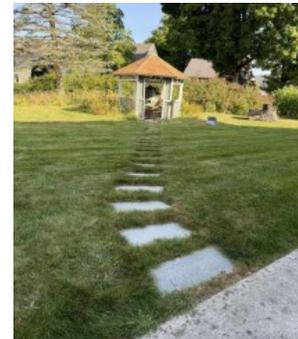
The accessible route contains loose gravel and/or surface materials that do not provide for a stable, firm slip resistant surface.

**Recommendation:**  
Install newly paved complete Accessible route from parking lot to Liberty Bell display

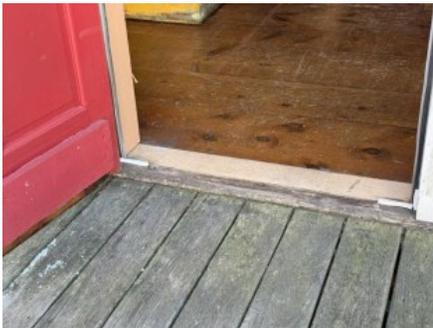
**External: Doorway**

Door threshold is sagging and needs to be replaced for safety purposes.

Replace sagging and rotted door threshold.

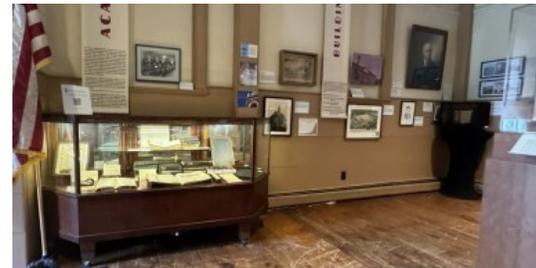
**Internal: Displays**

All information displayed, regardless of height, lack QR codes and other display information necessary to assist blind and low vision customers and visitors from enjoying each displayed item. At the very least signage with raised lettering and braille should be provided for each displayed item.

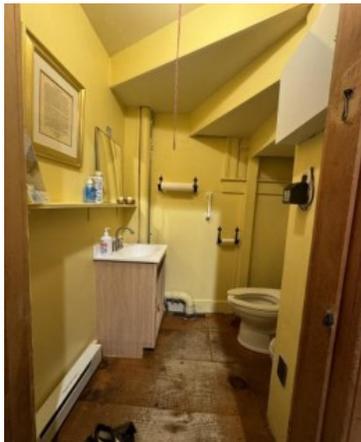
**Internal: Restroom**

The toilet compartment does not meet the minimum size requirements.

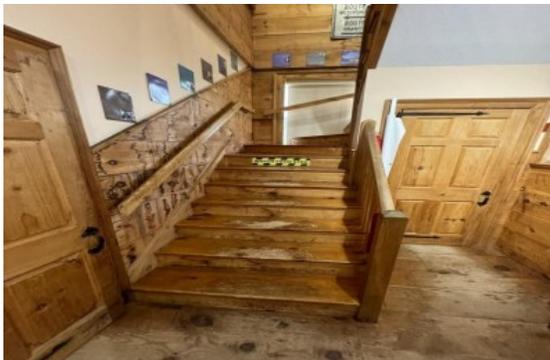
**Finding: 938517 Additional Finding Photos**

**Internal: No Access to Second Floor**

There is no access for those who use mobility devices to access displays located on the second floor
